the **play inspection** company

Annual Inspection

Wacton Parish Council

The Green

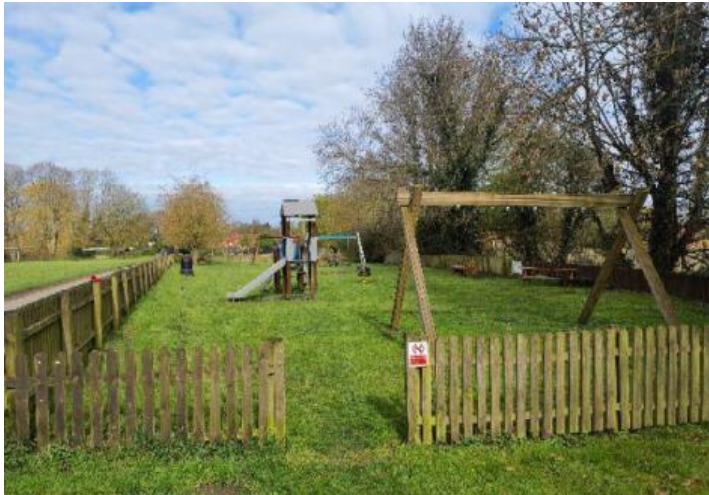
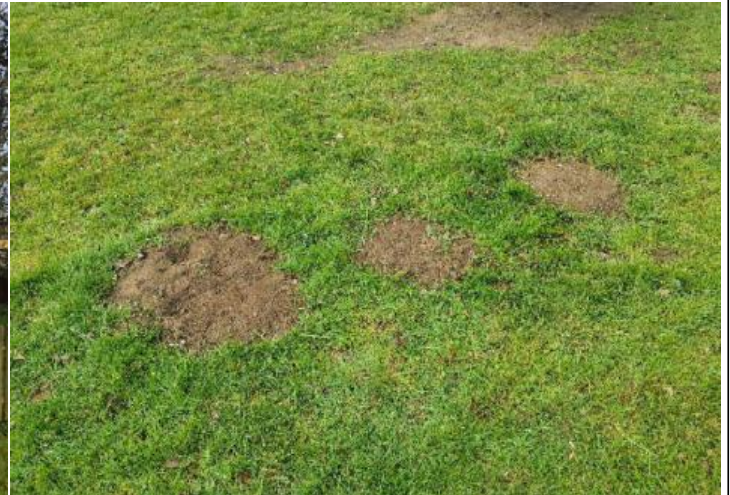
Item: Ancillary Items - Site General
Manufacturer: Owner/Operator

There are a number of molehills within the area and these may present unforeseen hazards for users - Remove moles by appropriate means, reinstate surfaces to level and maintain the area

Risk Level: L - Low Risk
Surface: N/A

Finding: There are a number of molehills within the area and these may present unforeseen hazards for users

Action: Remove moles by appropriate means, reinstate surfaces to level and maintain the area

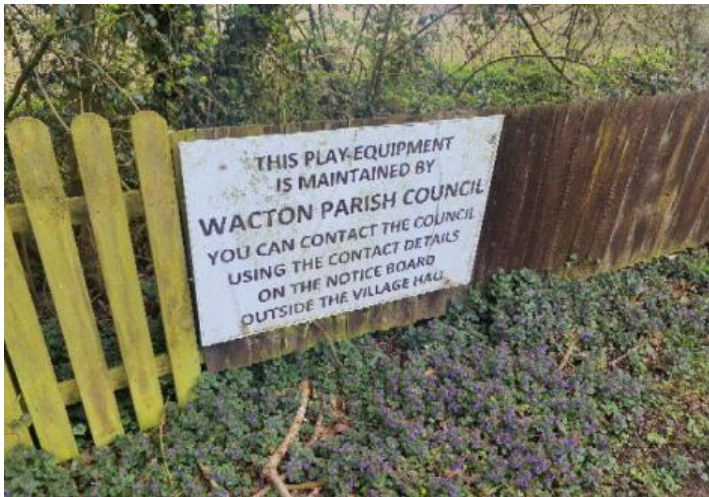
Item: Ancillary Items - Sign
Manufacturer: Not Identified

Finding: It is recommended that signage, with information including the site address, contact information for maintenance issues and emergency contact details are provided for the facility

Action: Provide in accordance with the recommendations

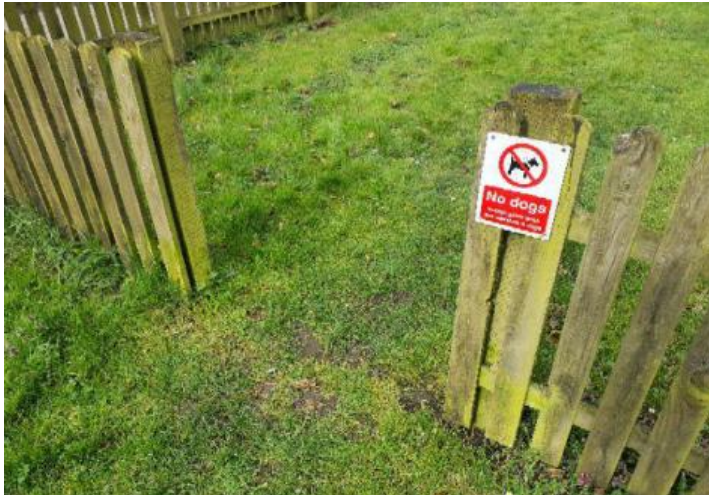
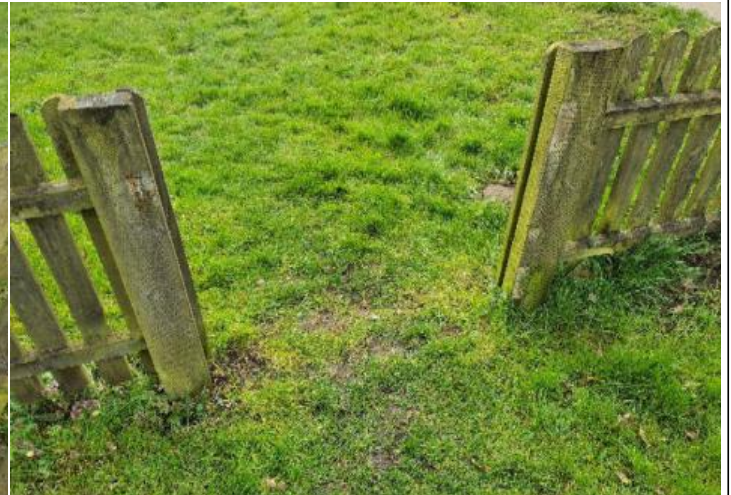
Item: Gates - Gate - Self Closing
Manufacturer: Not Identified

Risk Level: L - Low Risk
Surface: Grass

Finding: Both gates have been removed

Action: Replace gates

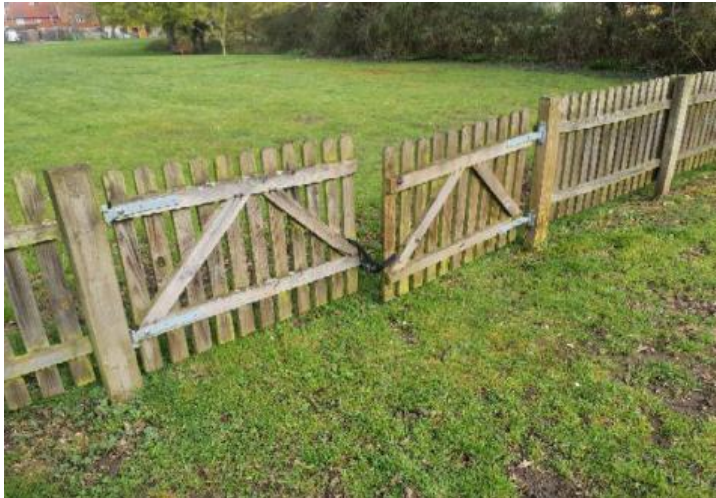
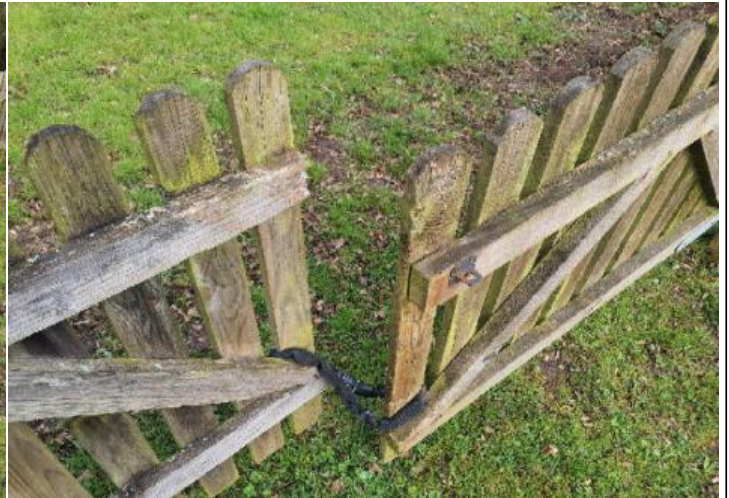
Item: Gates - Gate - Maintenance
Manufacturer: Not Identified

Risk Level: L - Low Risk
Surface: Grass

Finding: The gate latch is damaged or missing

Action: Repair or replace

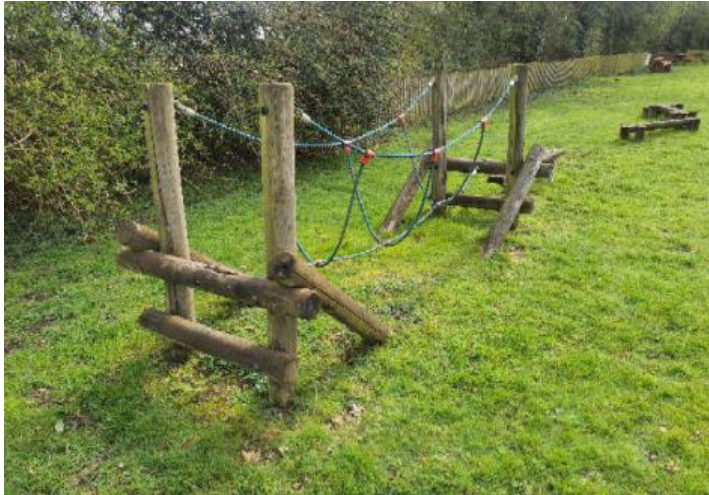
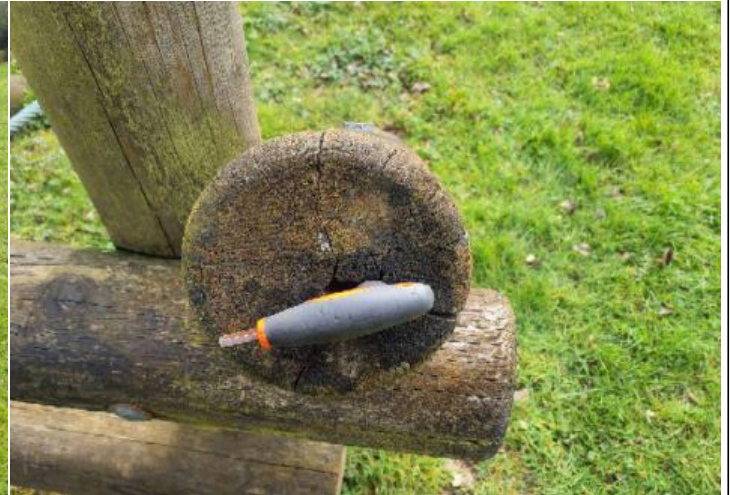
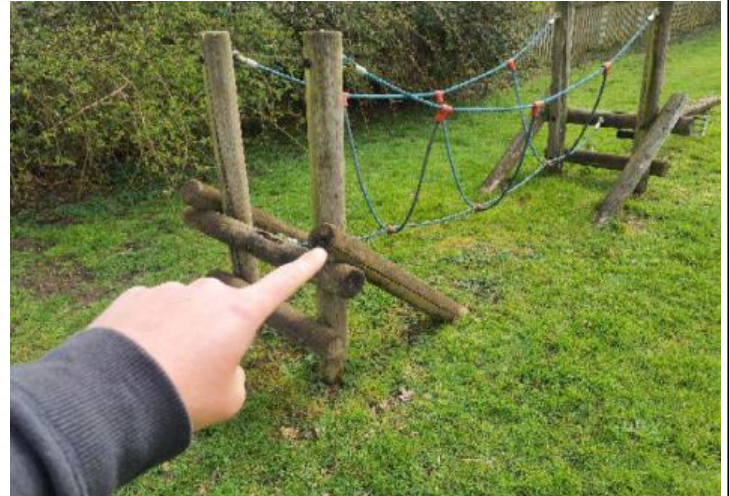
Item: Activity Equipment - Burma Bridge
Manufacturer: Fenland Leisure Products

Risk Level: M - Moderate Risk
Surface: Grass

Finding: There are areas or parts of the timber on the structure that have rotted

Action: Replace all affected timbers

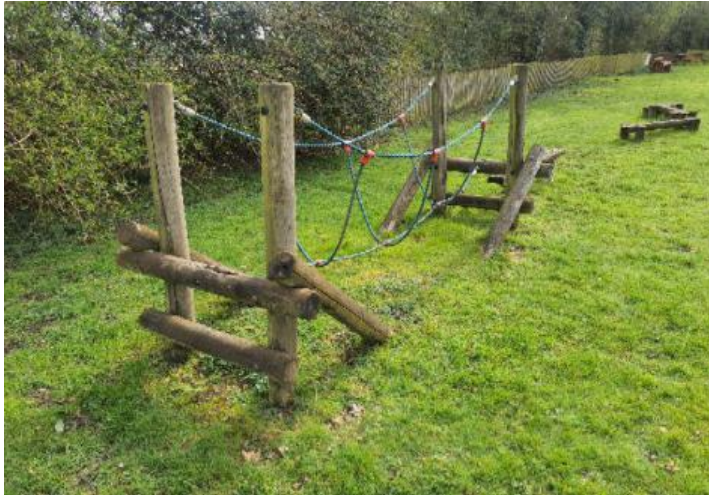
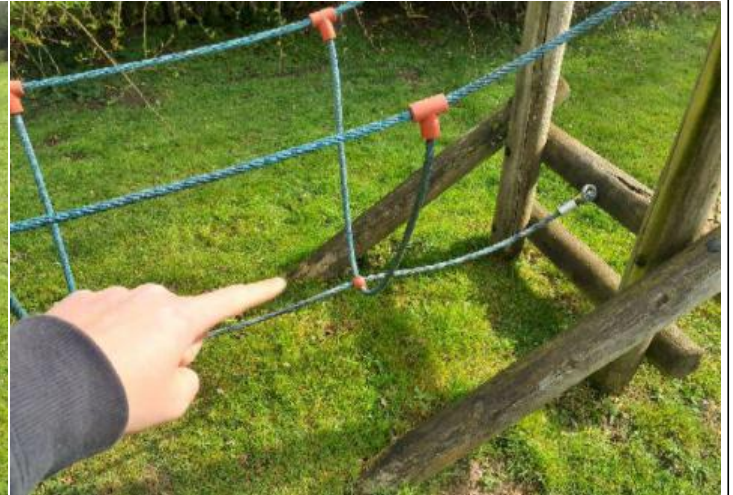
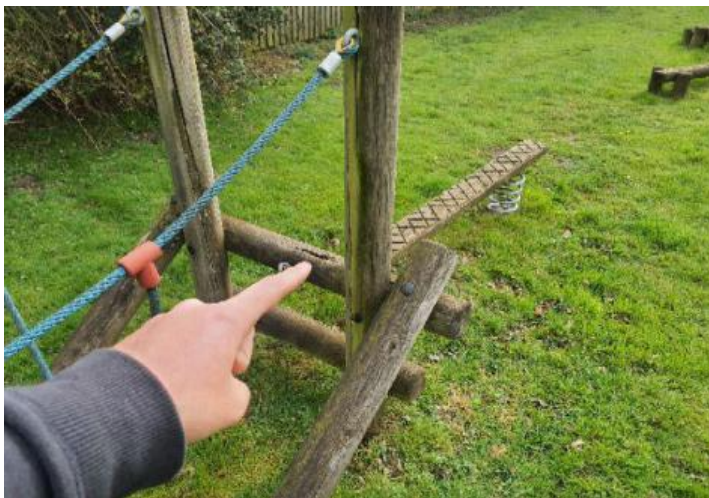
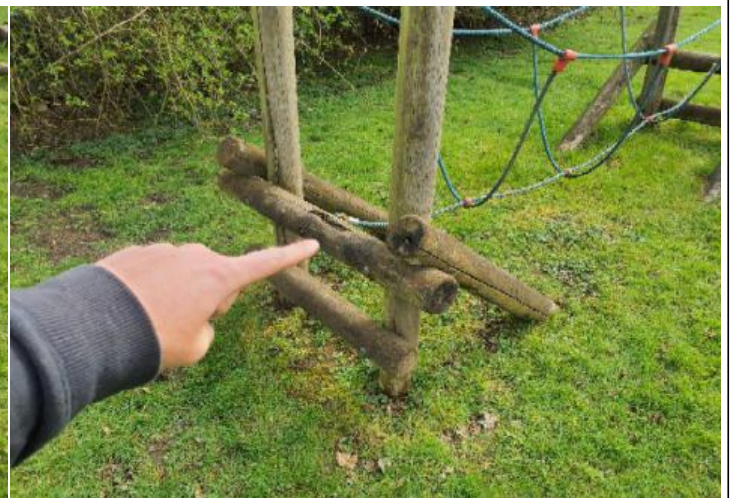
Item: Activity Equipment - Burma Bridge
Manufacturer: Fenland Leisure Products

Risk Level: M - Moderate Risk
Surface: Grass

Finding: There are areas or parts of the timber on the structure that have rotted

Action: Replace all affected timbers

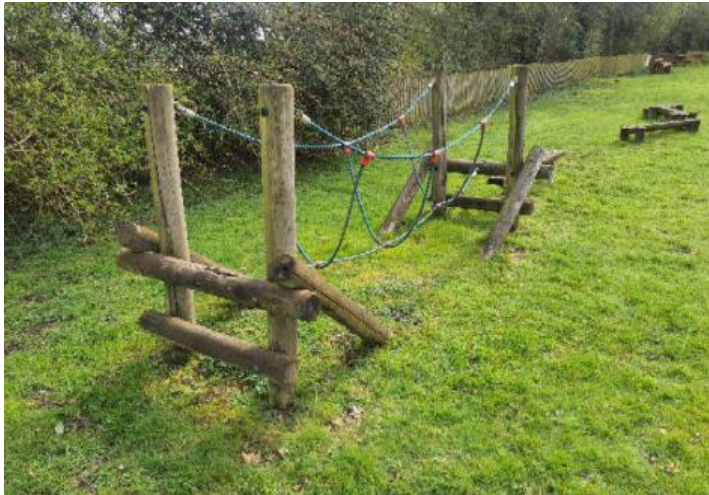
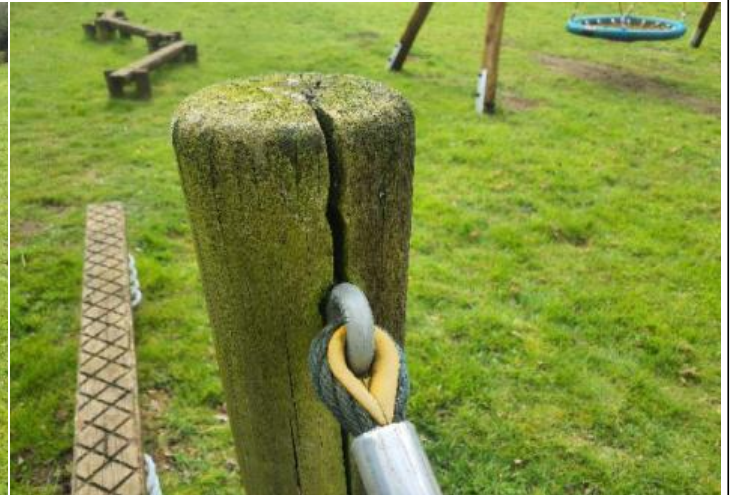
Item: Activity Equipment - Burma Bridge
Manufacturer: Fenland Leisure Products

Risk Level: L - Low Risk
Surface: Grass

Finding: There are splits in the timber running through fixing points and creating some instability in the structure
Action: Tighten fixings or replace all affected timber parts as required

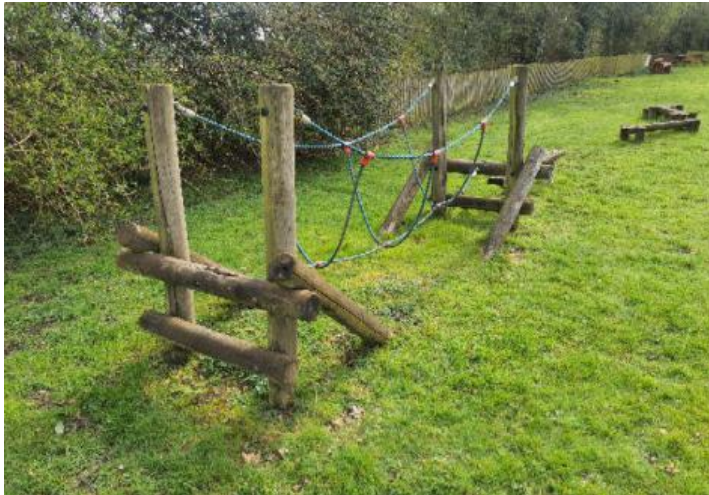
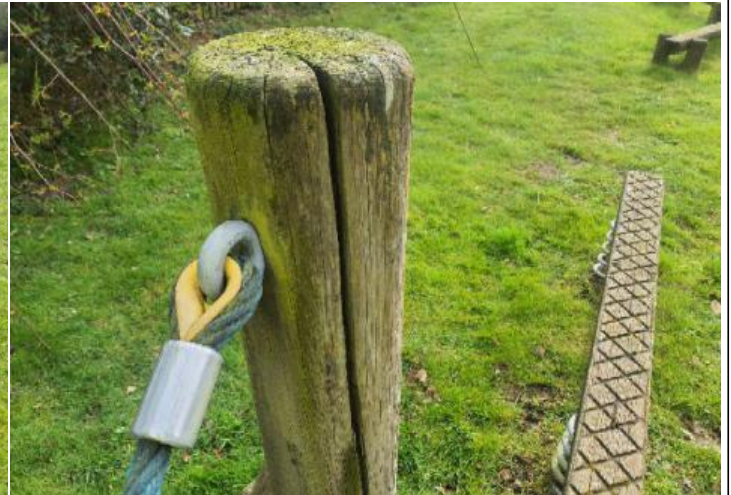
Item: Activity Equipment - Burma Bridge
Manufacturer: Fenland Leisure Products

Risk Level: L - Low Risk
Surface: Grass

Finding: The timber has a number of splits/shakes or air cracks and this may affect the stability or allow water ingress which will accelerate the rotting process. Timber splits may also create rough / splintering edges.

Action: Monitor, sand down any rough edges and ensure the splits do not cross through fixing points of the structure and/or cause any instability

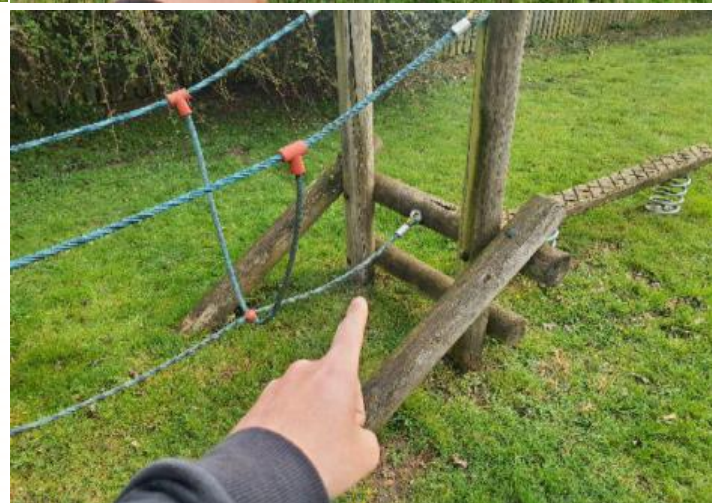
Finding: There are areas or parts of the timber on the structure that have rotted

Action: Replace all affected timbers

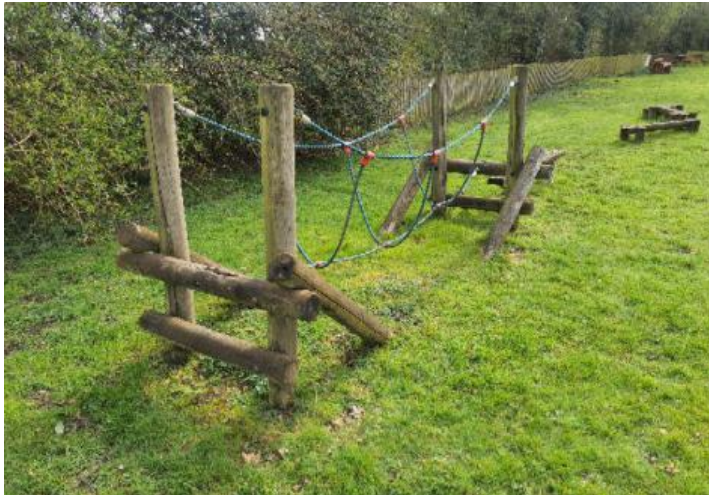
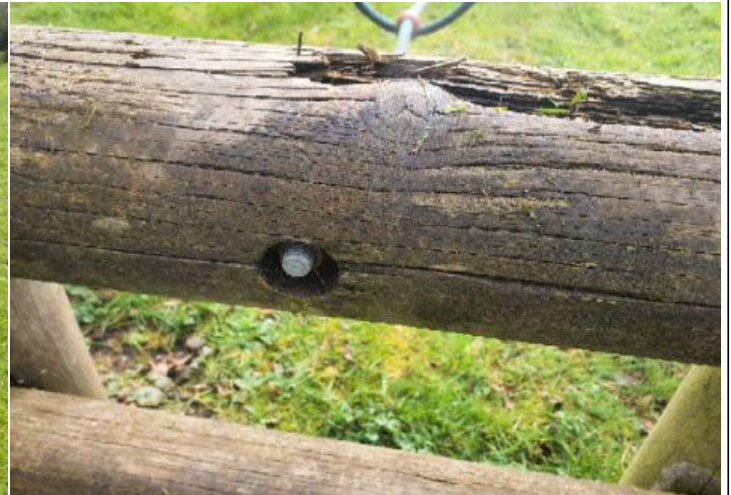
Item: Activity Equipment - Burma Bridge
Manufacturer: Fenland Leisure Products

Risk Level: V - Very Low Risk
Surface: Grass

Finding: Bolt cap cover/s missing or damaged

Action: Replace

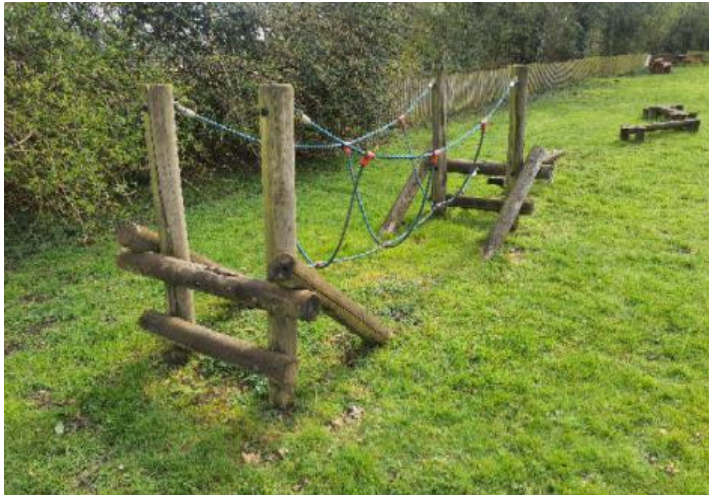
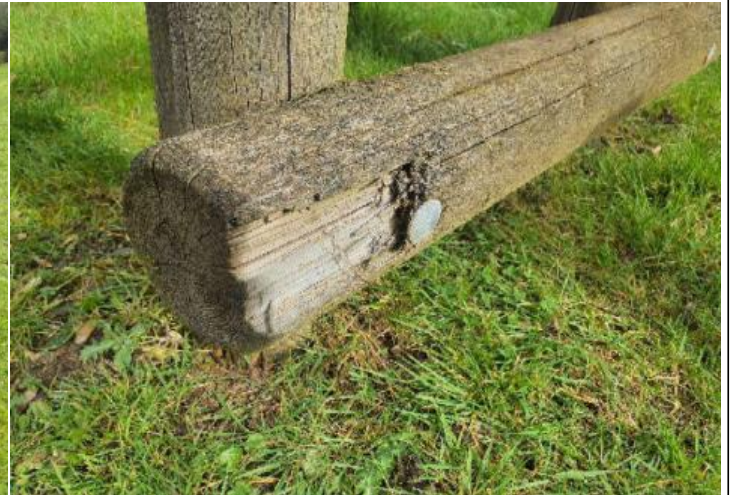
Item: Activity Equipment - Burma Bridge
Manufacturer: Fenland Leisure Products

Risk Level: L - Low Risk
Surface: Grass

Finding: There is some strimmer / machinery damage apparent on the posts, this can penetrate the preservative applied to the timber and accelerate the rotting process

Action: Monitor for any deterioration (rot) and replace as required

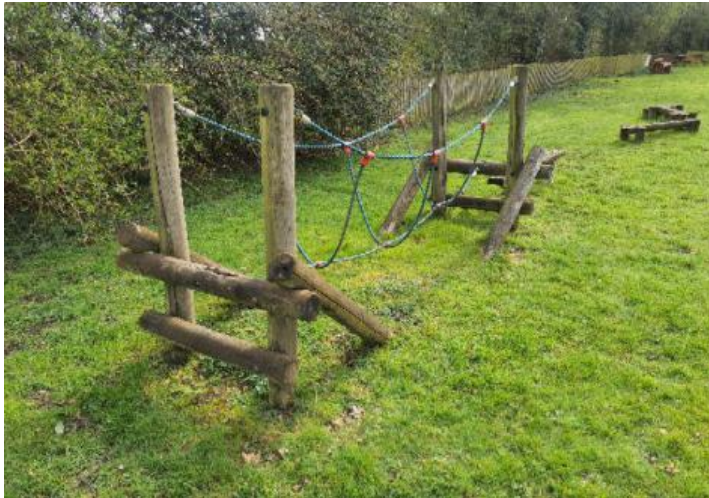
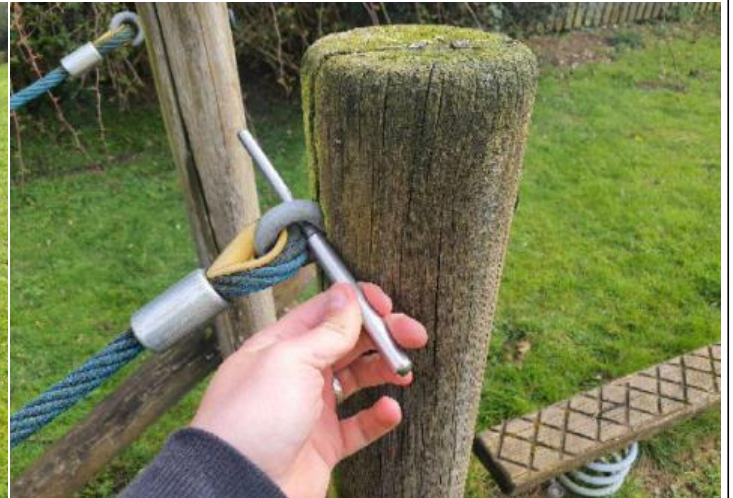
Item: Activity Equipment - Burma Bridge
Manufacturer: Fenland Leisure Products

Risk Level: V - Very Low Risk
Surface: Grass

Finding: The connecting links are in excess of 8.6mm and less than 12mm and fail the requirements of BS EN 1176 Part 1; clause 4.2.13, Chains

Action: Monitor use and replace with compliant links at the next maintenance cycle

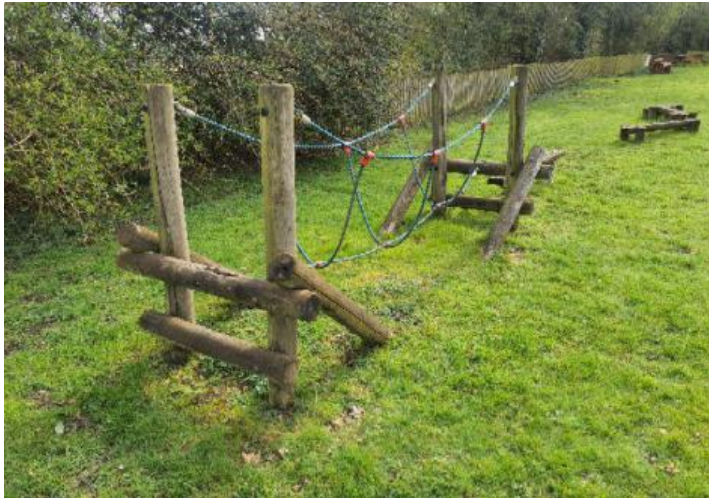
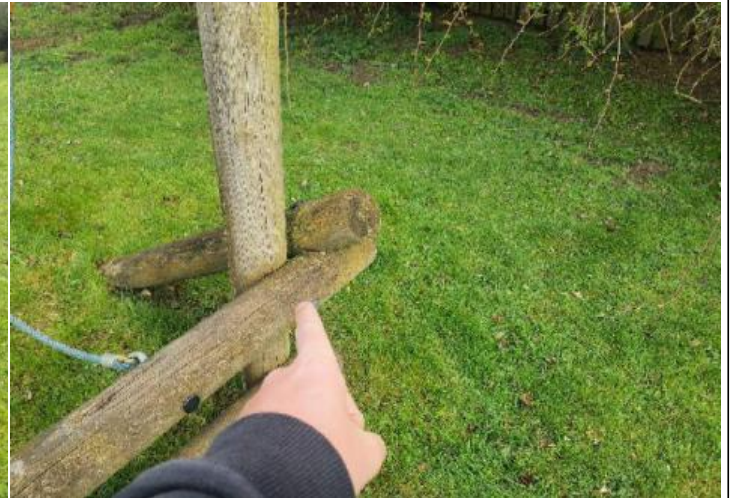
Item: Activity Equipment - Burma Bridge
Manufacturer: Fenland Leisure Products

Risk Level: L - Low Risk
Surface: Grass

Finding: A number of fixing(s) have worked loose

Action: Secure all loose fixings

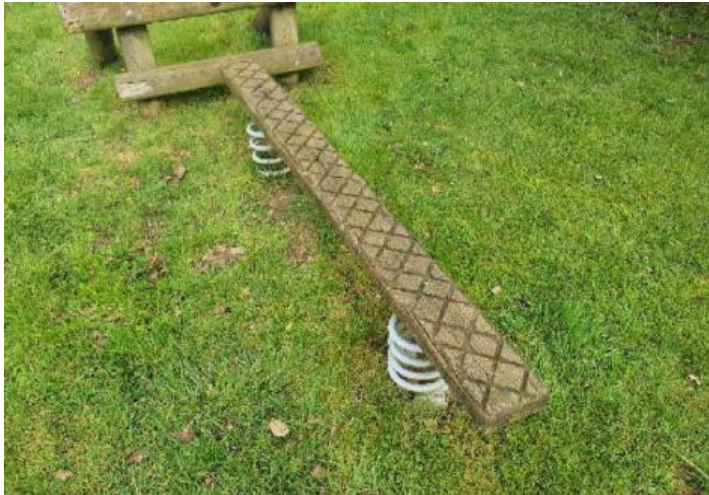
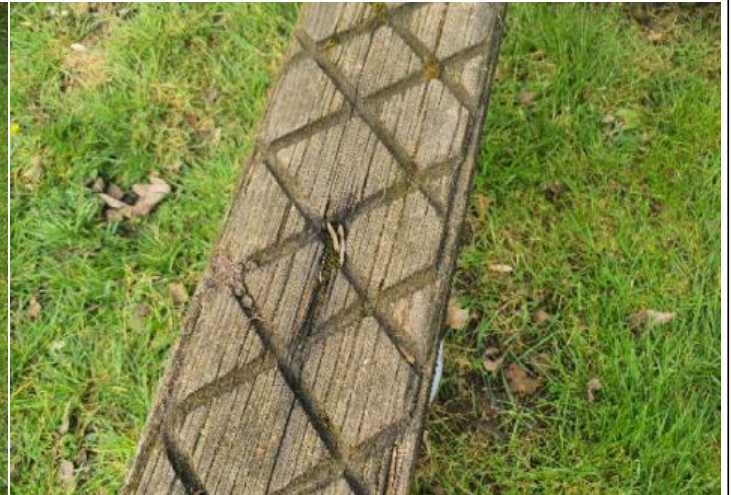
Item: Activity Equipment - Spring Balance Beam **Risk Level:** L - Low Risk
Manufacturer: Fenland Leisure Products **Surface:** Grass

Finding: There is some evidence of rot in the timber

Action: Monitor for any further deterioration and replace as required

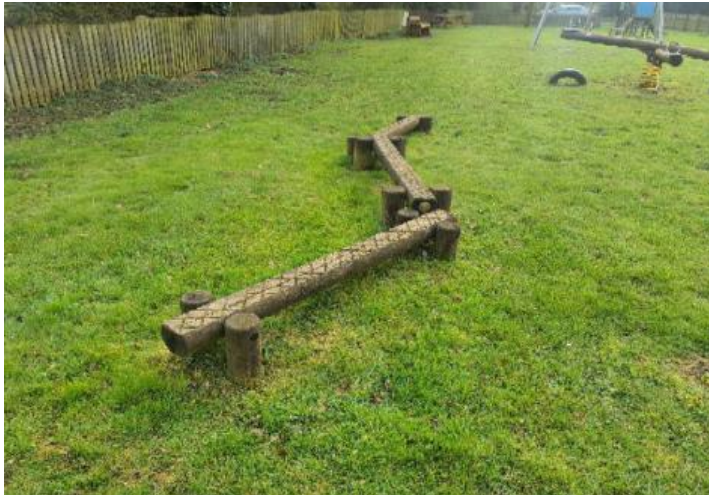
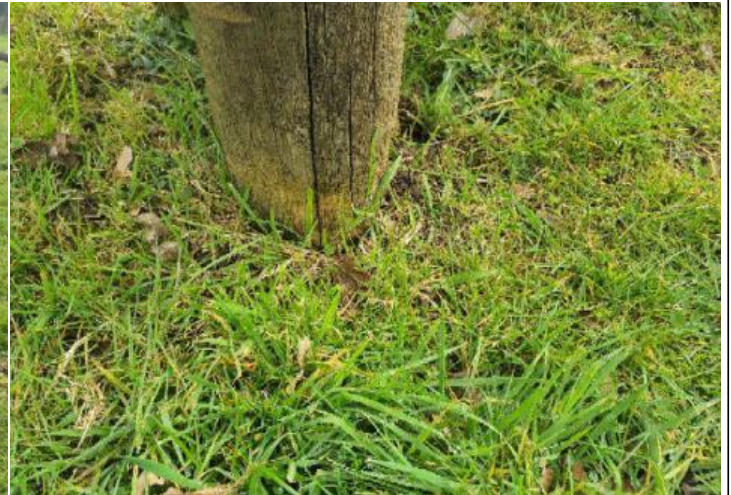
Item: Activity Equipment - Balance Beam
Manufacturer: Not Identified

Risk Level: L - Low Risk
Surface: Grass

Finding: There is some strimmer / machinery damage apparent on the posts, this can penetrate the preservative applied to the timber and accelerate the rotting process

Action: Monitor for any deterioration (rot) and replace as required

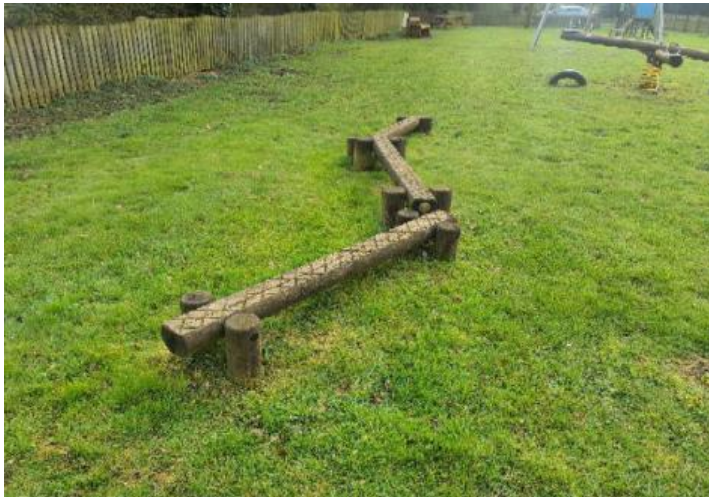
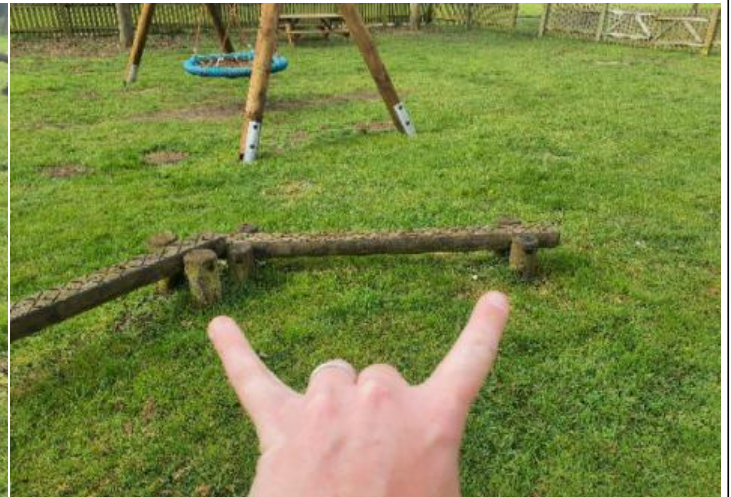
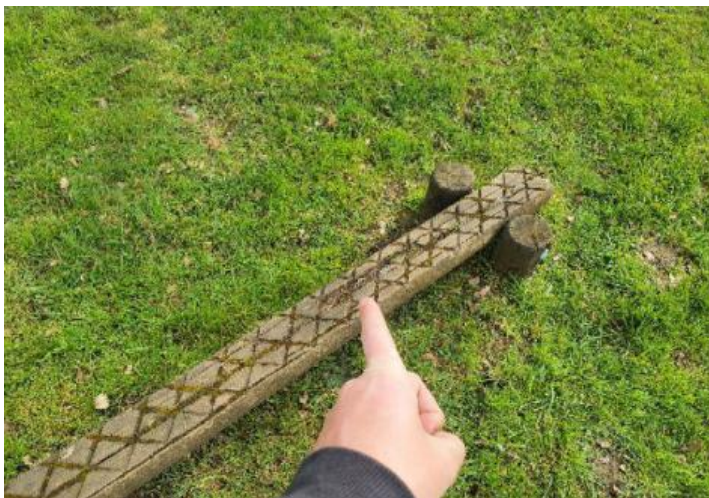
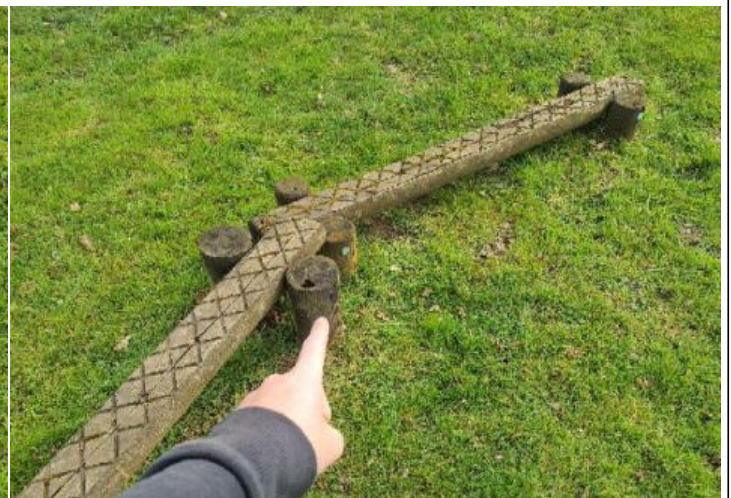
Item: Activity Equipment - Balance Beam
Manufacturer: Not Identified

Risk Level: M - Moderate Risk
Surface: Grass

Finding: There are areas or parts of the timber on the structure that have rotted

Action: Replace all affected timbers

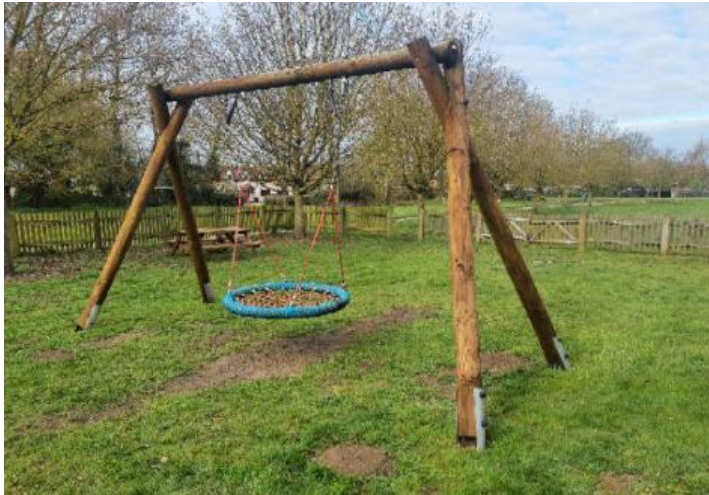
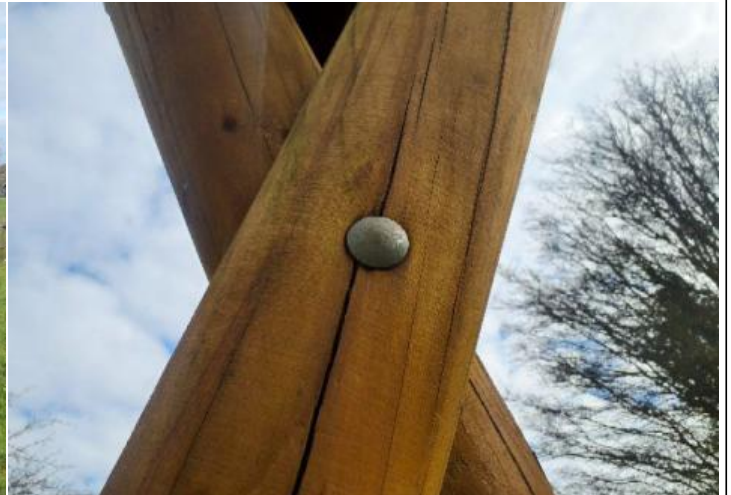
Item: Swings - Basket Swing - Type 1
Manufacturer: NGF Play

Risk Level: L - Low Risk
Surface: Grass Matrix Tiles

Finding: The timber has a number of splits/shakes or air cracks and this may affect the stability or allow water ingress which will accelerate the rotting process. Timber splits may also create rough / splintering edges.

Action: Monitor, sand down any rough edges and ensure the splits do not cross through fixing points of the structure and/or cause any instability

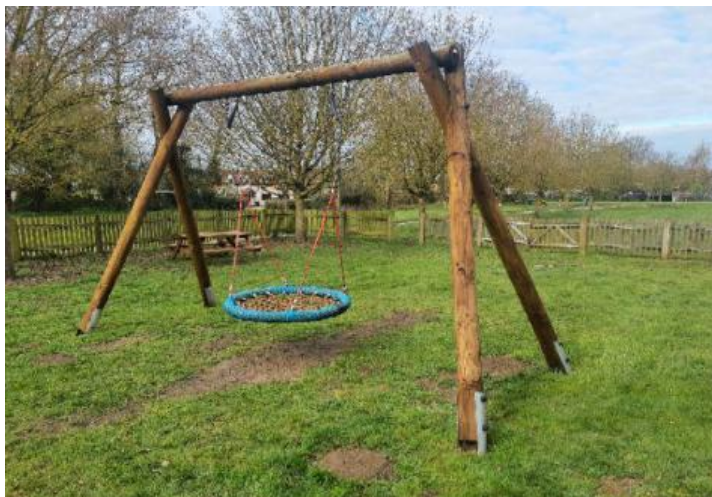
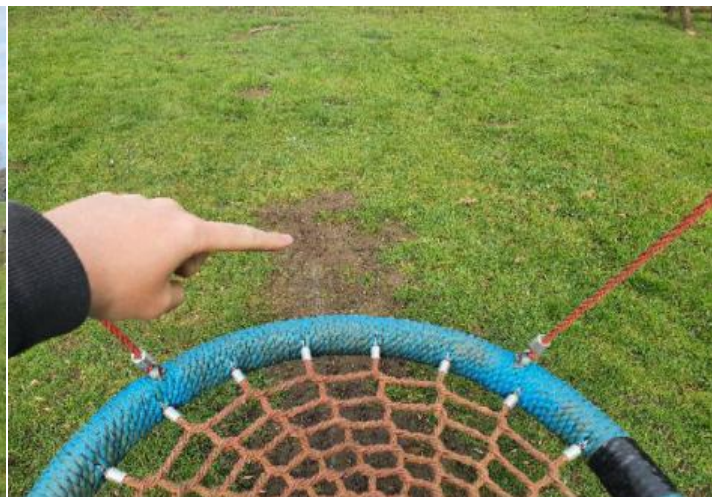
Item: Swings - Basket Swing - Type 1
Manufacturer: NGF Play

Risk Level: L - Low Risk
Surface: Grass Matrix Tiles

Finding: The surface has subsided in some areas

Action: Monitor for any further deterioration and repair as required

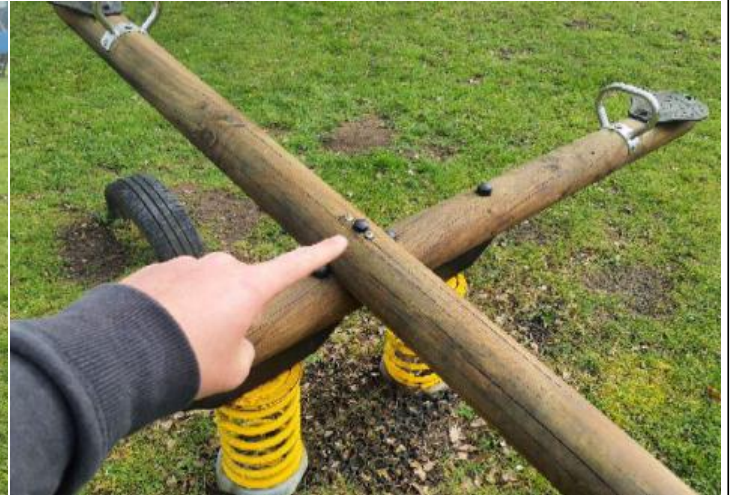
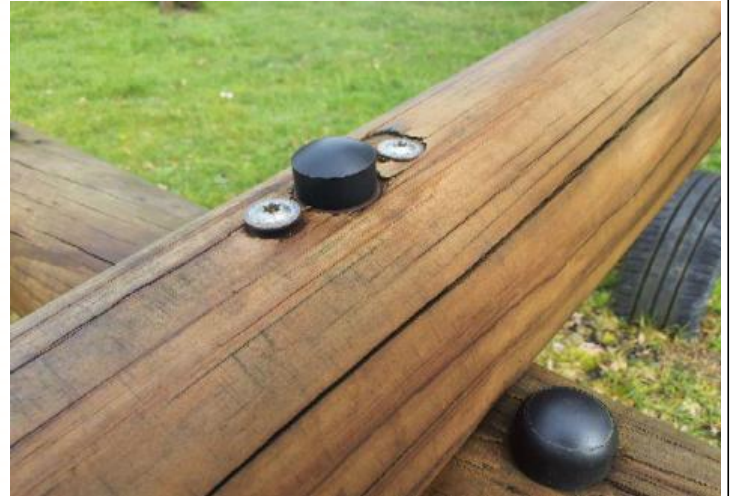
Item: Rocking Equipment - Four Way Springer
Manufacturer: NGF Play

Risk Level: M - Moderate Risk
Surface: Grass Matrix Tiles

Finding: A number of fixing(s) have worked loose and there is a significant amount of movement
Action: Secure all loose fixings

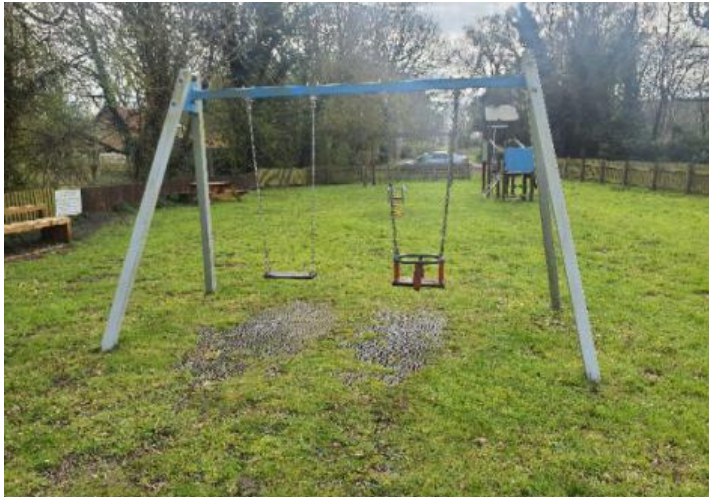
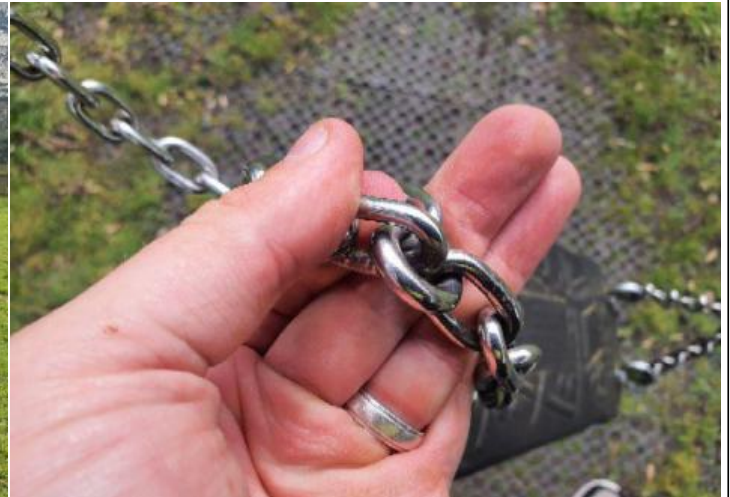
Item: Swings - 1 Bay Mixed Seat, 1 Cradle, 1 Flat
Manufacturer: Vinci Play

Risk Level: L - Low Risk
Surface: Grass Matrix Tiles

Finding: There is some notable evidence of chain wear

Action: Monitor for any further deterioration and replace when 40% worn

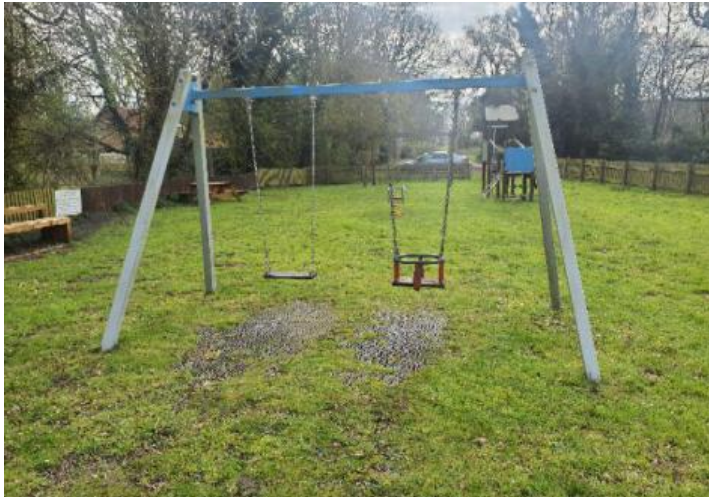
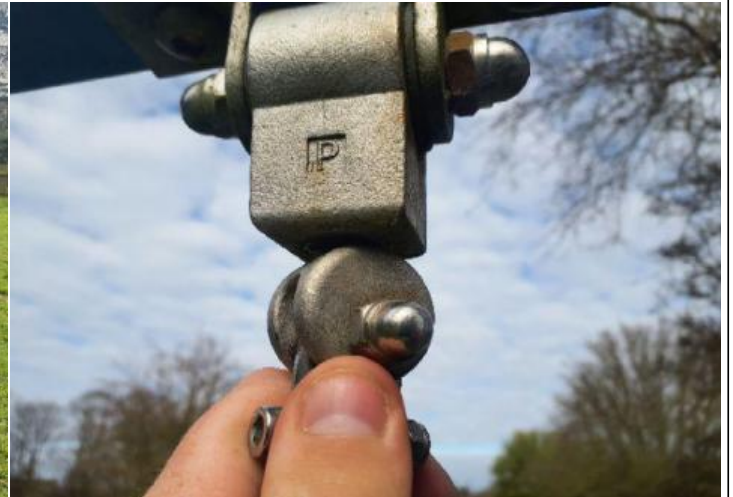
Finding: The suspension fixings are showing signs of wear **Action:** Monitor for any further deterioration and replace as required

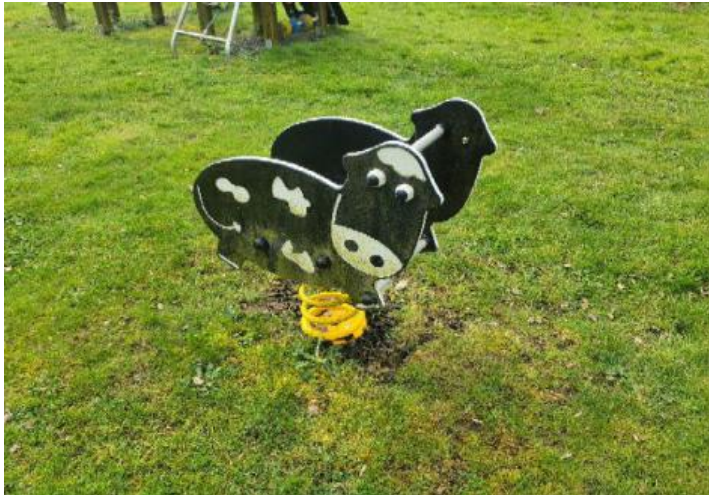
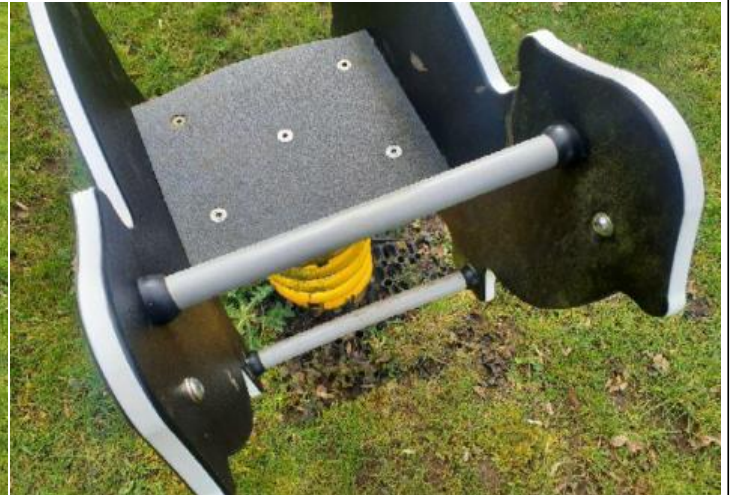
Item: Rocking Equipment - Spring Cow
Manufacturer: Fahr Industries

Risk Level: L - Low Risk
Surface: Grass Matrix Tiles

Finding: The Handgrips/Footrests rotate and may cause an unexpected movement for the user **Action:** Secure Handgrips/Footrests to prevent rotation.

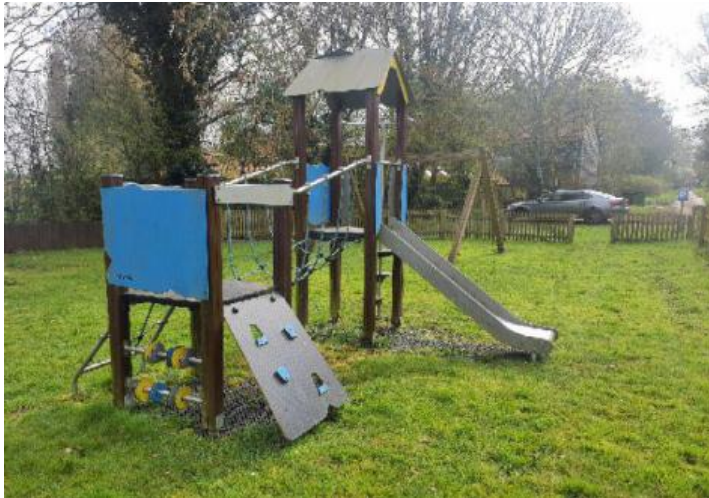
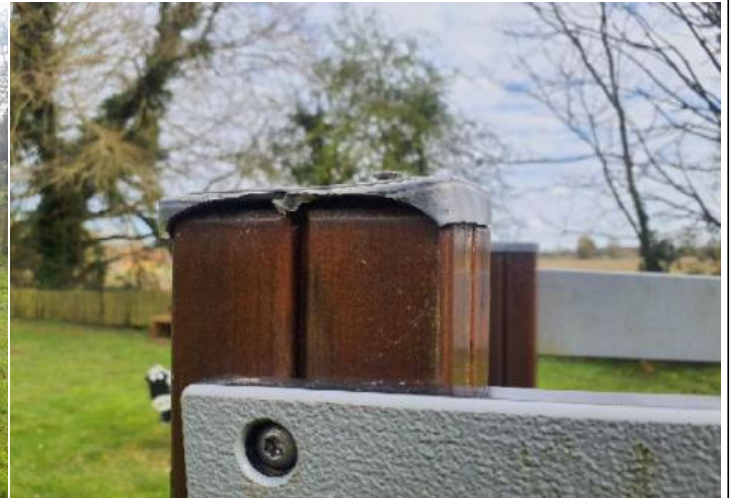
Item: Activity Equipment - Multi Play (Junior)
Manufacturer: Vinci Play

Risk Level: L - Low Risk
Surface: Grass Matrix Tiles

Finding: There is / are post or end caps missing / damaged **Action:** Replace missing / damaged post or end caps on the item

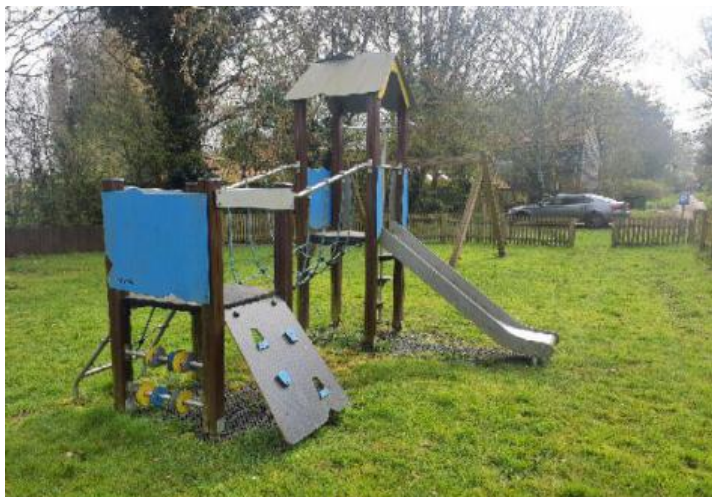
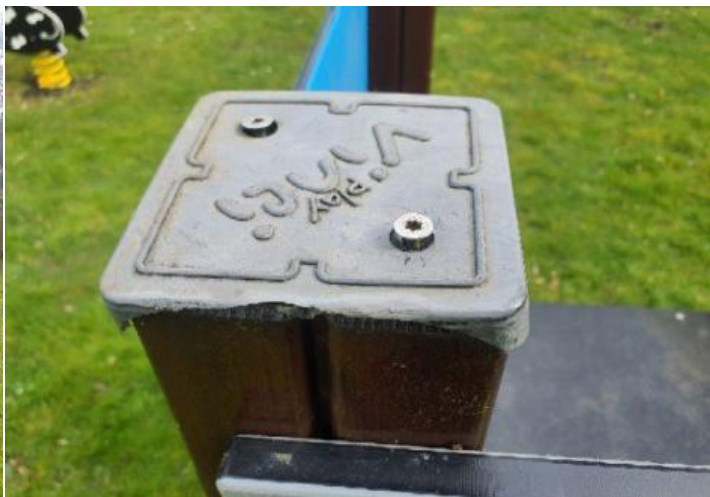
Item: Activity Equipment - Multi Play (Junior)
Manufacturer: Vinci Play

Risk Level: L - Low Risk
Surface: Grass Matrix Tiles

Finding: A number of fixing(s) have worked loose

Action: Secure all loose fixings

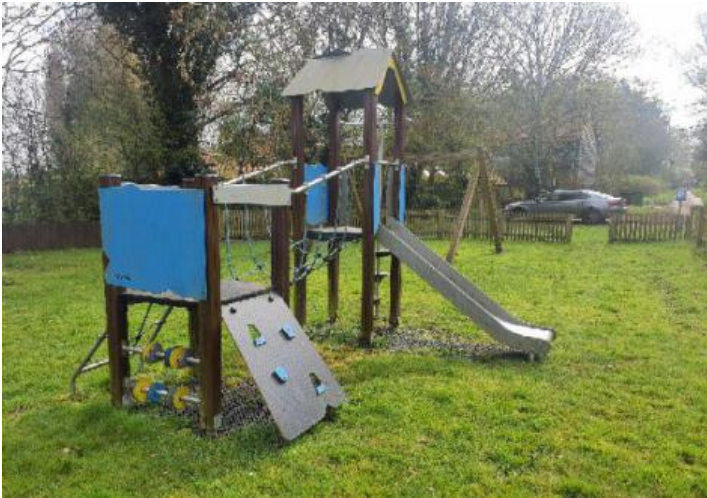
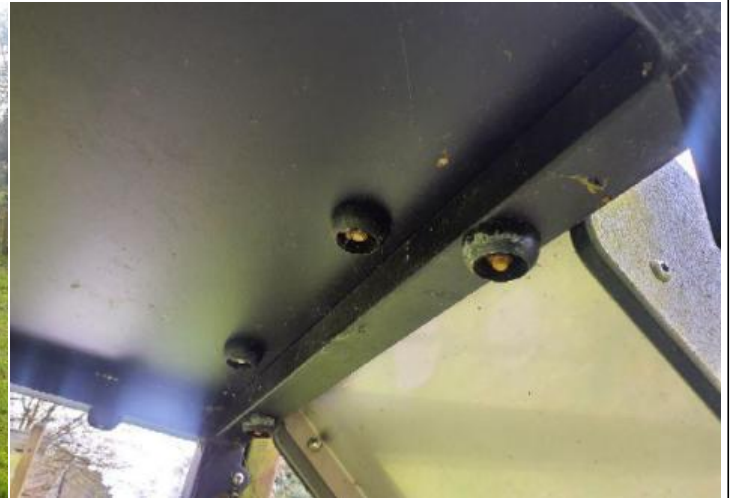
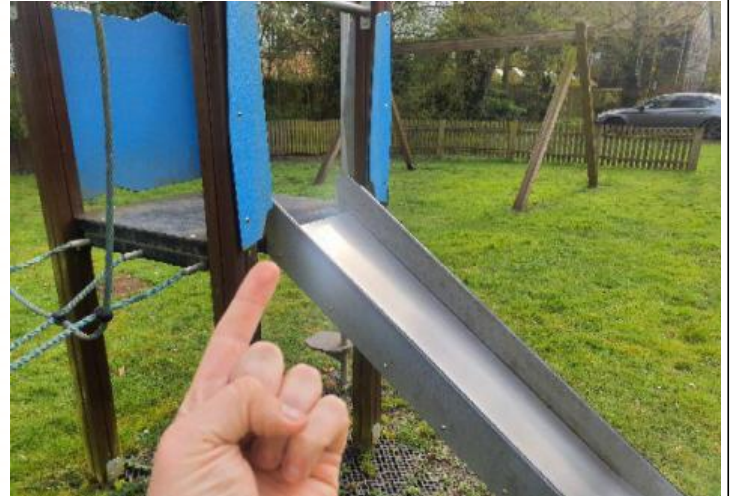
Item: Activity Equipment - Multi Play (Junior)
Manufacturer: Vinci Play

Risk Level: V - Very Low Risk
Surface: Grass Matrix Tiles

Finding: Bolt cap cover/s missing or damaged

Action: Replace

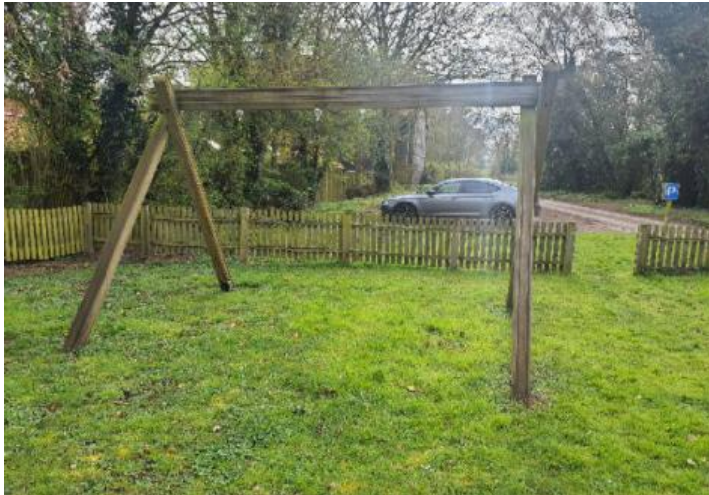
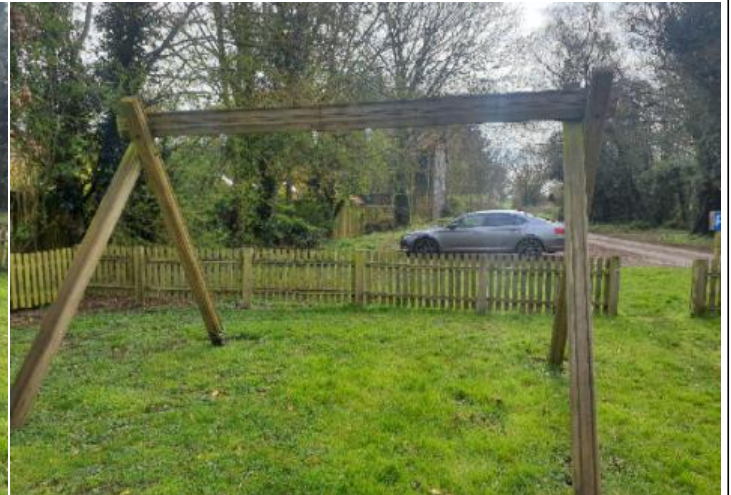
Item: Swings - 1 Bay 2 Seat (Cradle)
Manufacturer: Fenland Leisure Products

Risk Level: N - Risk Assessment not Undertaken
Surface: Grass Matrix Tiles

Finding: The seat(s) and suspension were missing at the time of inspection and the inspector was unable to make a full compliance assessment

Action: Replace missing seat(s) and suspension(s) (subject to any other findings needing correction)

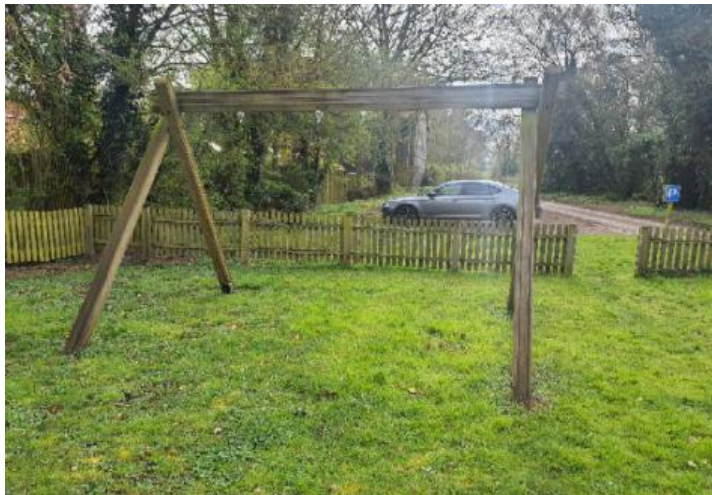
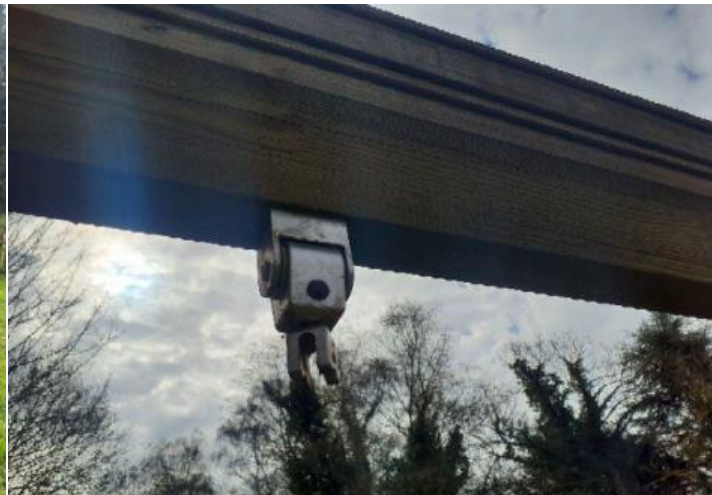
Item: Swings - 1 Bay 2 Seat (Cradle)
Manufacturer: Fenland Leisure Products

Risk Level: N - Risk Assessment not Undertaken
Surface: Grass Matrix Tiles

Finding: This design of swing joint has been known to fail on the weld connecting the joint to the threaded stud

Action: We would recommend that the joint be dismantled and checked on a regular basis or consulting with manufacturer on whether a Secondary Safety Device can be fitted
