the **play inspection** company

Annual Inspection

Wacton Parish Council

The Green

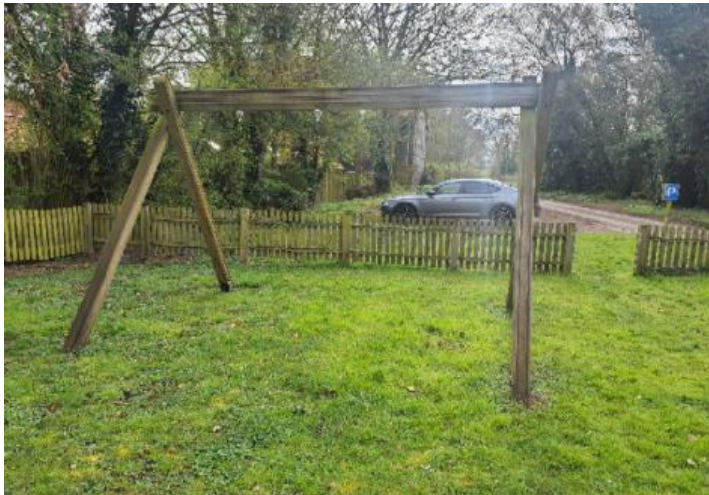
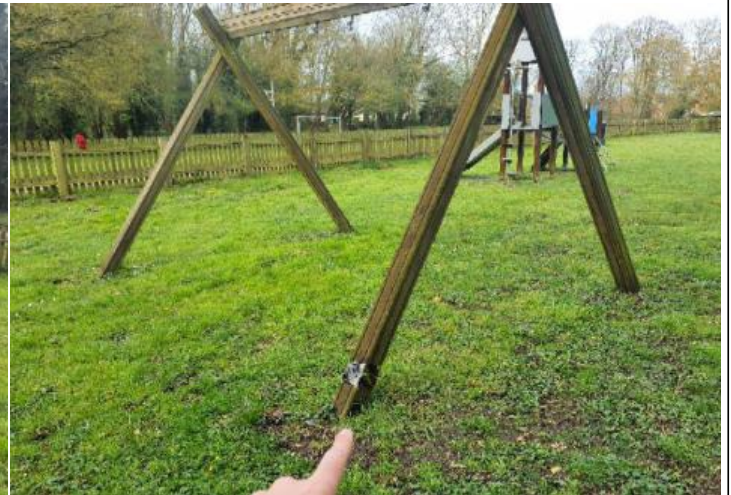
Item: Swings - 1 Bay 2 Seat (Cradle)
Manufacturer: Fenland Leisure Products

Risk Level: M - Moderate Risk
Surface: Grass Matrix Tiles

Finding: The timber on this item has severe rot and has snapped at ground level

Action: Remove and replace all affected timber sections before replacing seats (risk assessment has been reduced due to missing seats)

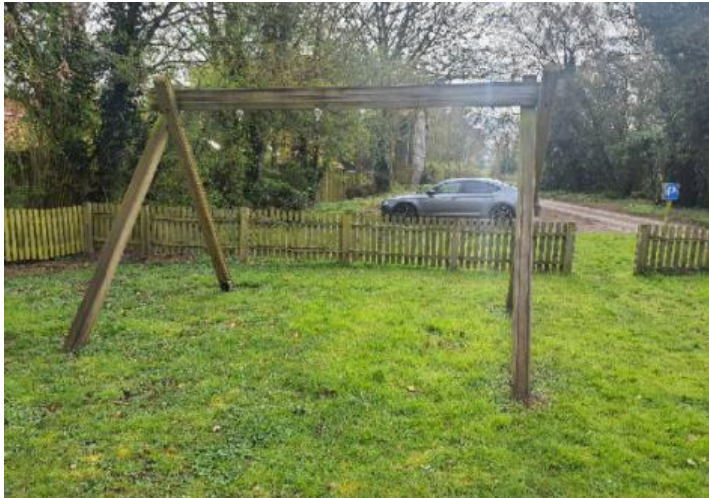
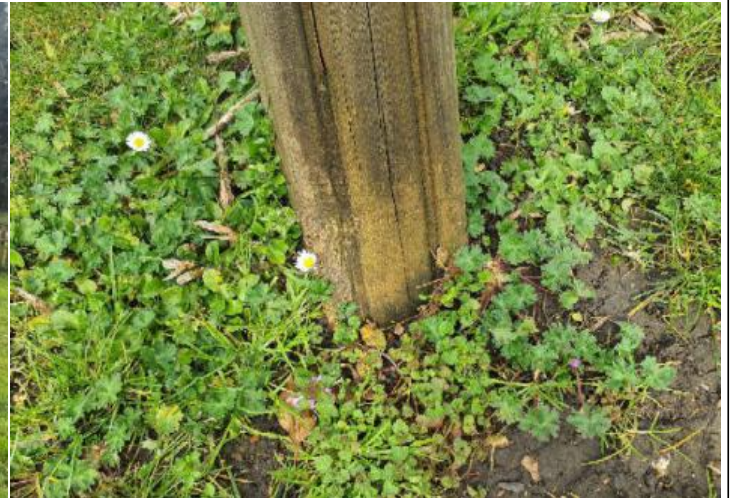
Item: Swings - 1 Bay 2 Seat (Cradle)
Manufacturer: Fenland Leisure Products

Risk Level: L - Low Risk
Surface: Grass Matrix Tiles

Finding: There is some strimmer / machinery damage apparent on the posts, this can penetrate the preservative applied to the timber and accelerate the rotting process

Action: Monitor for any deterioration (rot) and replace as required

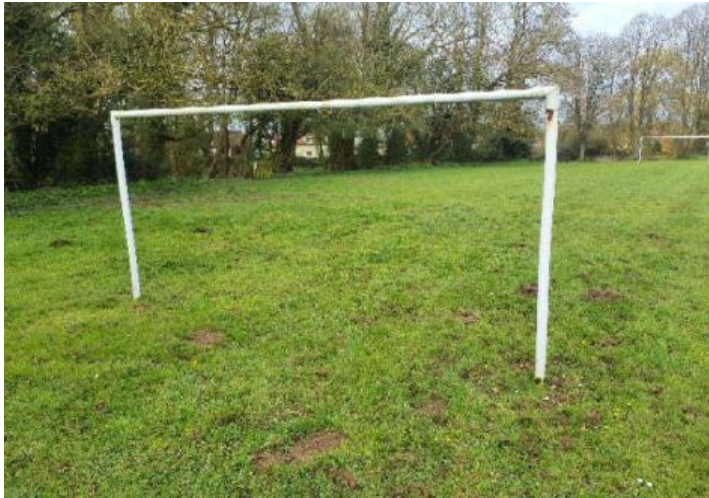
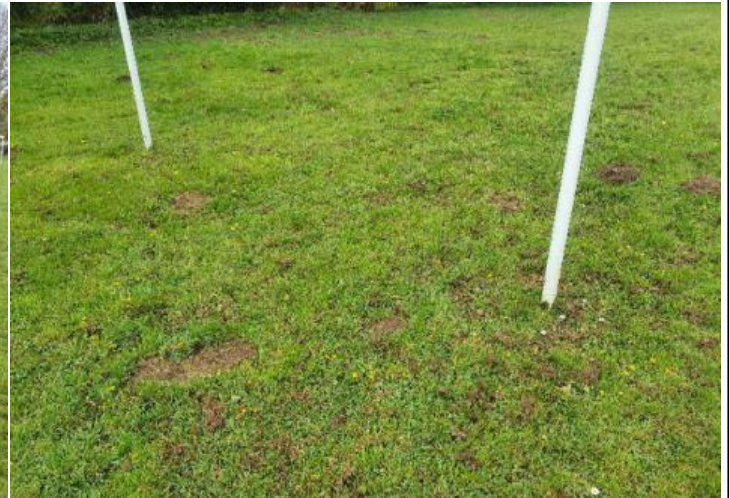
Item: Multi Use Games Area - 5 a side Goals
Manufacturer: Not Identified

Risk Level: L - Low Risk
Surface: Grass

Finding: The goals are not anchored in position and can be lifted out of the socket

Action: Refer to manufacturer recommendations and provide as required

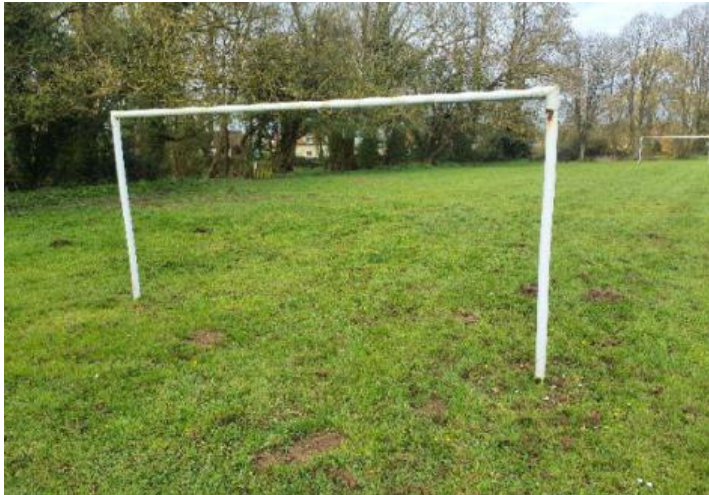
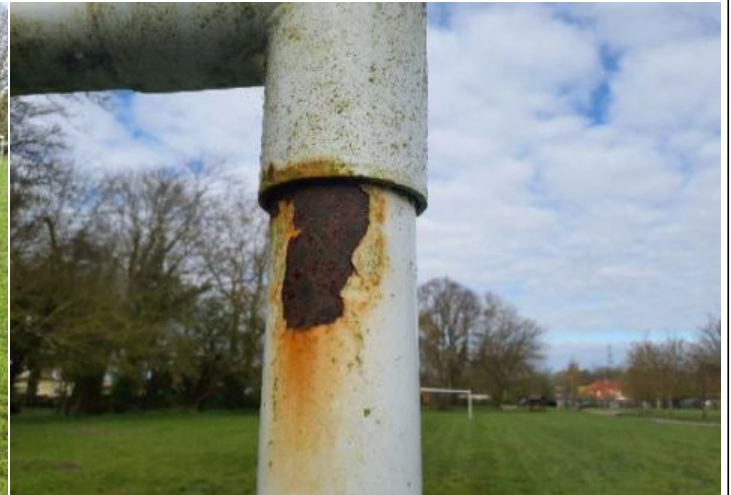
Item: Multi Use Games Area - 5 a side Goals
Manufacturer: Not Identified

Risk Level: L - Low Risk
Surface: Grass

Finding: The paintwork on this item has been damaged or worn exposing the metal underneath which is rusting / corroding

Action: Treat affected areas and repaint

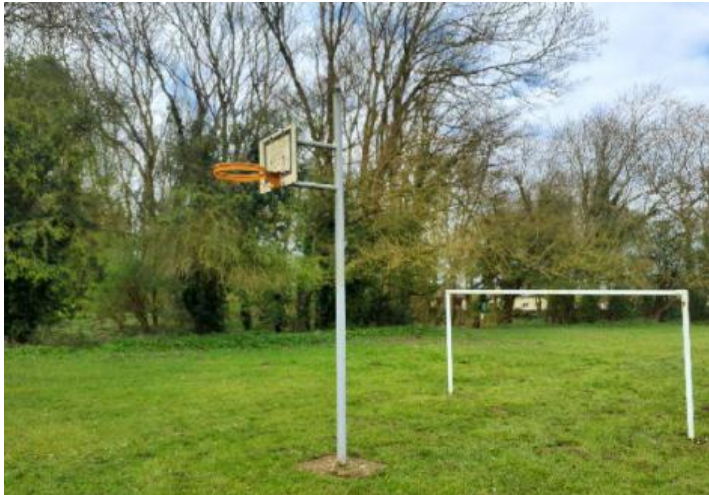
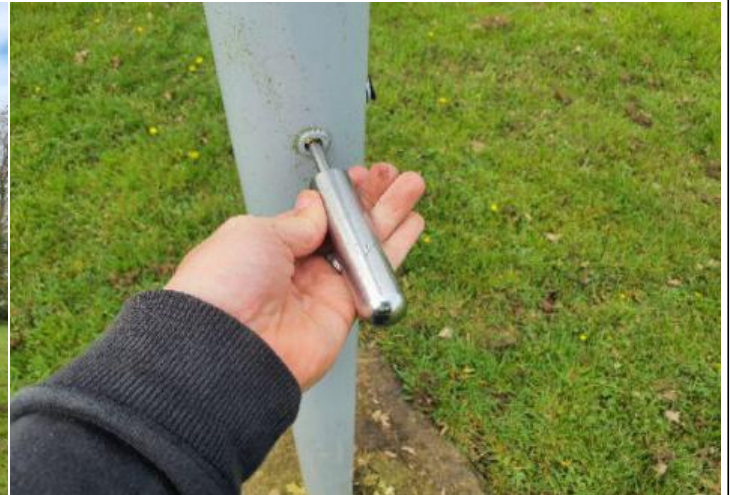
Item: Multi Use Games Area - Basketball Post
Manufacturer: Not Identified

Risk Level: V - Very Low Risk
Surface: Grass

Finding: There is/are finger entrapments in the post due to missing inserts and the item fails to meet the requirements of BS EN 15312 Clause 4.4.2.2 Entrapment of fingers

Action: Provide inserts to remove entrapment f

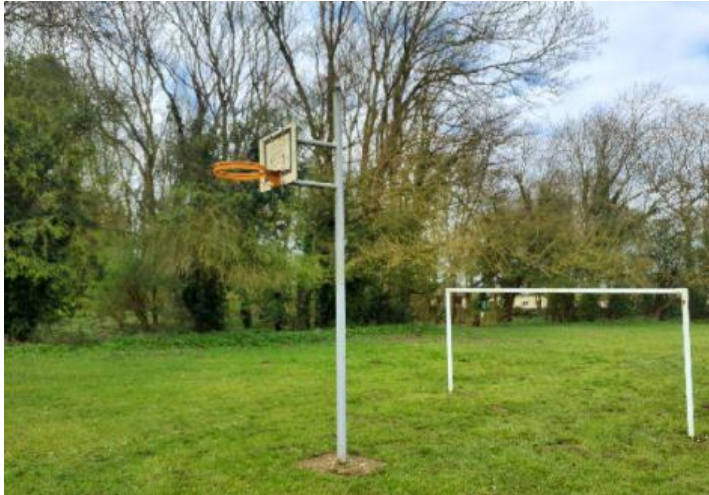
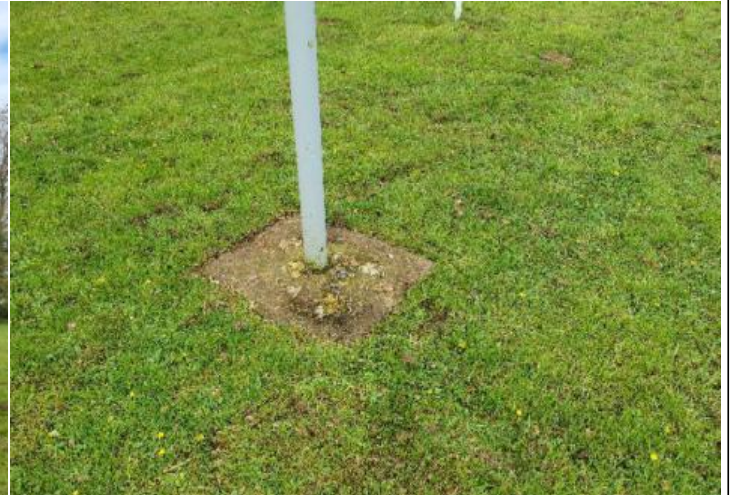
Item: Multi Use Games Area - Basketball Post
Manufacturer: Not Identified

Risk Level: M - Moderate Risk
Surface: Grass

Finding: The item is loose in its foundations

Action: Reinstall item to secure
