the **play inspection** company

Annual Inspection

Wacton Parish Council

The Green

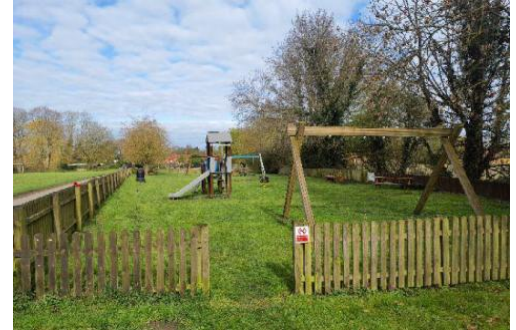
Item: Site General
Manufacturer: Owner/Operator
Surface Type: N/A
Item Quantity: 1
Equipment Compliance: N/A
Surface Area Compliance: N/A

The adjacent foliage is overhanging - Cut back and maintain

There are a number of molehills within the area and these may present unforeseen hazards for users - Remove moles by appropriate means, reinstate surfaces to level and maintain the area

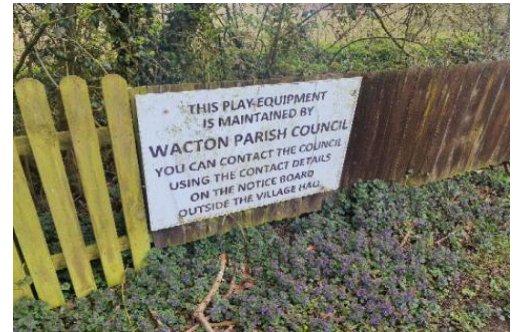
Item: Sign
Manufacturer: Not Identified
Surface Type: N/A
Item Quantity: 1
Equipment Compliance: N/A
Surface Area Compliance: N/A

It is recommended that signage, with information including the site address, contact information for maintenance issues and emergency contact details are provided for the facility - Provide in accordance with the recommendations

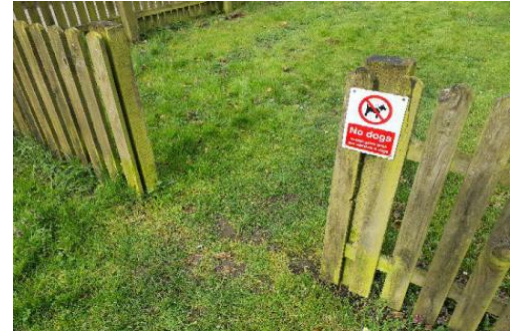
Item: Gate - Self Closing
Manufacturer: Not Identified
Surface Type: Grass
Item Quantity: 1
Equipment Compliance: N/A
Surface Area Compliance: N/A

Both gates have been removed - Replace gates

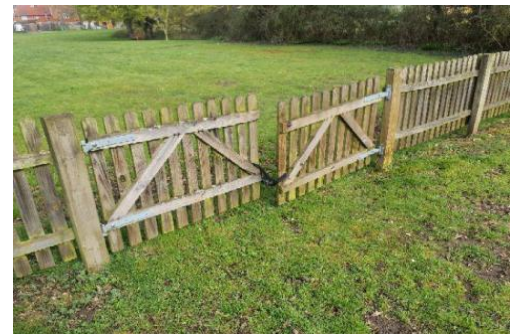
Item: Gate - Maintenance
Manufacturer: Not Identified
Surface Type: Grass
Item Quantity: 1
Equipment Compliance: N/A
Surface Area Compliance: N/A

The gate latch is damaged or missing - Repair or replace

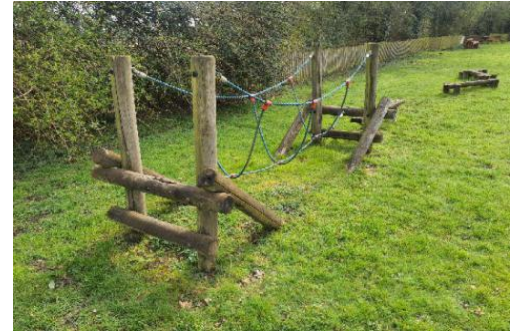
Item: Burma Bridge
Manufacturer: Fenland Leisure Products
Surface Type: Grass
Item Quantity: 1
Equipment Compliance: No
Surface Area Compliance: Yes
Life Expectancy: <12 Months
Total Findings: 9

There are areas or parts of the timber on the structure that have rotted - Replace all affected timbers

There are splits in the timber running through fixing points and creating some instability in the structure - Tighten fixings or replace all affected timber parts as required

The timber has a number of splits/shakes or air cracks and this may affect the stability or allow water ingress which will accelerate the rotting process. Timber splits may also create rough / splintering edges. - Monitor, sand down any rough edges and ensure the splits do not cross through fixing points of the structure and/or cause any instability

Bolt cap cover/s missing or damaged - Replace

There is some strimmer / machinery damage apparent on the posts, this can penetrate the preservative applied to the timber and accelerate the rotting process - Monitor for any deterioration (rot) and replace as required

The connecting links are in excess of 8.6mm and less than 12mm and fail the requirements of BS EN 1176 Part 1; clause 4.2.13, Chains - Monitor use and replace with compliant links at the next maintenance cycle

A number of fixing(s) have worked loose - Secure all loose fixings

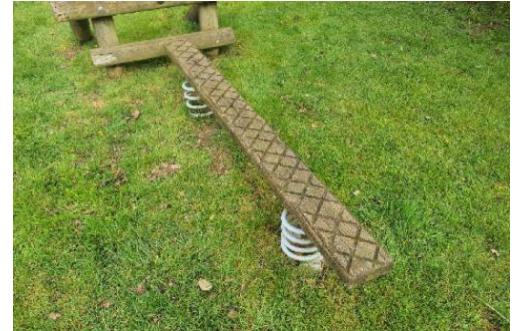
Item: Spring Balance Beam
Manufacturer: Fenland Leisure Products
Surface Type: Grass
Item Quantity: 1
Equipment Compliance: No
Surface Area Compliance: Yes
Life Expectancy: 5 -10 Years
Total Findings: 2

The redundant post forms a hard object within the impact area of the equipment in contravention of the requirements of BS EN 1176 Part 1 - Remove post

There is some evidence of rot in the timber - Monitor for any further deterioration and replace as required

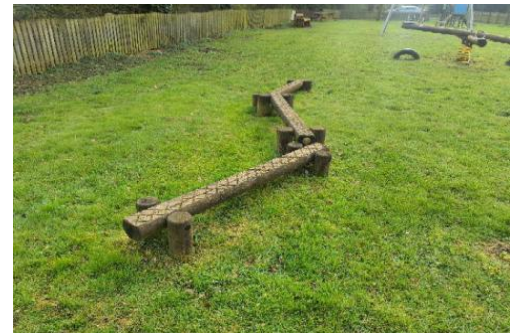
Item: Balance Beam
Manufacturer: Not Identified
Surface Type: Grass
Item Quantity: 1
Equipment Compliance: Yes
Surface Area Compliance: Yes
Life Expectancy: <12 Months
Total Findings: 2

There is some strimmer / machinery damage apparent on the posts, this can penetrate the preservative applied to the timber and accelerate the rotting process - Monitor for any deterioration (rot) and replace as required

There are areas or parts of the timber on the structure that have rotted - Replace all affected timbers

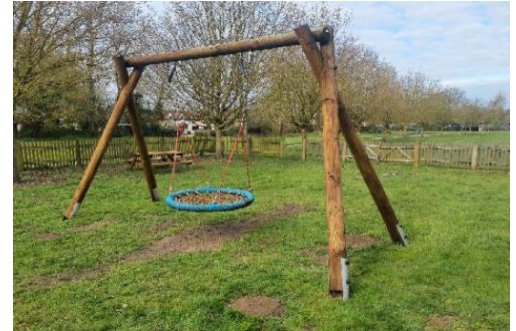
Item: Basket Swing - Type 1
Manufacturer: NGF Play
Surface Type: Grass Matrix Tiles
Item Quantity: 1
Equipment Compliance: Yes
Surface Area Compliance: Yes
Life Expectancy: 5 -10 Years
Total Findings: 3

The grass mats are silted up and the soil is compacted; this may have an effect on the impact absorbing properties of the surface. Consideration should be given to HIC testing the surface to verify impact attenuating properties (<https://playinspections.co.uk/inspection-services/safety-surface-testing/>) - Contact our office for a quotation for this service

The timber has a number of splits/shakes or air cracks and this may affect the stability or allow water ingress which will accelerate the rotting process. Timber splits may also create rough / splintering edges. - Monitor, sand down any rough edges and ensure the splits do not cross through fixing points of the structure and/or cause any instability

The surface has subsided in some areas - Monitor for any further deterioration and repair as required

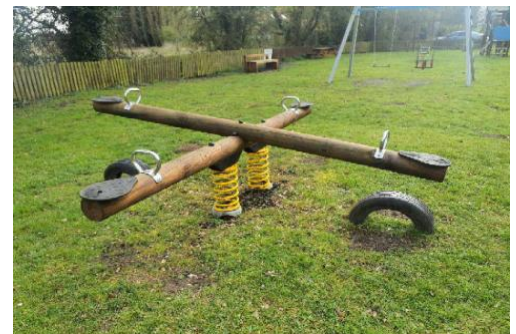
Item: Four Way Springer
Manufacturer: NGF Play
Surface Type: Grass Matrix Tiles
Item Quantity: 1
Equipment Compliance: Yes
Surface Area Compliance: Yes
Life Expectancy: 5 -10 Years
Total Findings: 3

The item is not level at rest - Adjust

A number of fixing(s) have worked loose and there is a significant amount of movement - Secure all loose fixings

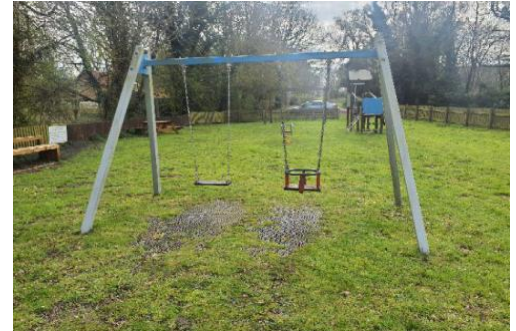
Item: 1 Bay Mixed Seat, 1 Cradle, 1 Flat
Manufacturer: Vinci Play
Surface Type: Grass Matrix Tiles
Item Quantity: 1
Equipment Compliance: Yes
Surface Area Compliance: Yes
Life Expectancy: >10 Years
Total Findings: 5

There is a lack of grass growth within the grassmats - Encourage grass growth

There is some notable evidence of chain wear - Monitor for any further deterioration and replace when 40% worn

The suspension fixings are showing signs of wear - Monitor for any further deterioration and replace as required

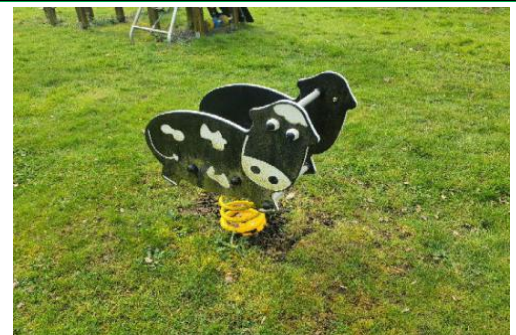
Item: Spring Cow
Manufacturer: Fahr Industries
Surface Type: Grass Matrix Tiles
Item Quantity: 1
Equipment Compliance: Yes
Surface Area Compliance: Yes
Life Expectancy: >10 Years
Total Findings: 1

The Handgrips/Footrests rotate and may cause an unexpected movement for the user - Secure Handgrips/Footrests to prevent rotation.

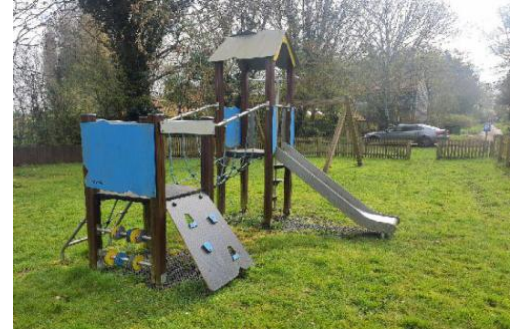
Item: Multi Play (Junior)
Manufacturer: Vinci Play
Surface Type: Grass Matrix Tiles
Item Quantity: 1
Equipment Compliance: Yes
Surface Area Compliance: Yes
Life Expectancy: >10 Years
Total Findings: 4

There is algae or moss on the surface of the equipment - Clean and treat appropriately

There is / are post or end caps missing / damaged on the item - Replace missing / damaged post or end caps

A number of fixing(s) have worked loose - Secure all loose fixings

Bolt cap cover/s missing or damaged - Replace

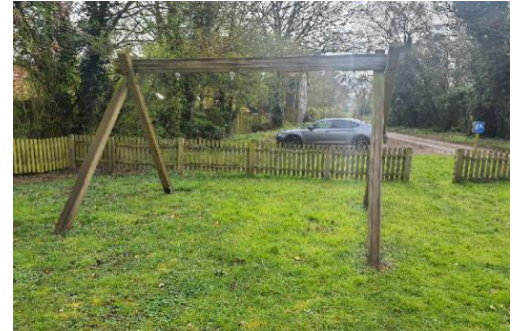
Item: 1 Bay 2 Seat (Cradle)
Manufacturer: Fenland Leisure Products
Surface Type: Grass Matrix Tiles
Item Quantity: 1
Equipment Compliance: N/A
Surface Area Compliance: N/A
Life Expectancy: 3 - 5 Years
Total Findings: 4

The seat(s) and suspension were missing at the time of inspection and the inspector was unable to make a full compliance assessment - Replace missing seat(s) and suspension(s) (subject to any other findings needing correction)

The timber on this item has severe rot and has snapped at ground level - Remove and replace all affected timber sections before replacing seats (risk assessment has been reduced due to missing seats)

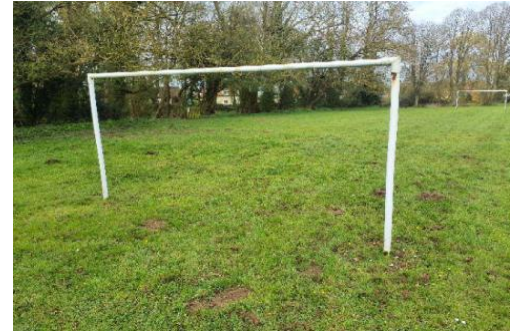
Item: 5 a side Goals
Manufacturer: Not Identified
Surface Type: Grass
Item Quantity: 1
Equipment Compliance: N/A
Surface Area Compliance: N/A
Life Expectancy: 5 -10 Years
Total Findings: 3

NB: We have undertaken a maintenance inspection only of the football goal(s); full load testing falls outside the scope of our inspection. - Implement load testing as required

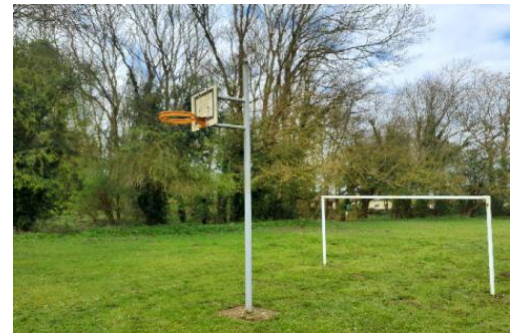
Item: Basketball Post
Manufacturer: Not Identified
Surface Type: Grass
Item Quantity: 1
Equipment Compliance: No
Surface Area Compliance: N/A
Life Expectancy: 5 -10 Years
Total Findings: 2

There is/are finger entrapments in the post due to missing inserts and the item fails to meet the requirements of BS EN 15312 Clause 4.4.2.2 Entrapment of fingers - Provide inserts to remove entrapment f

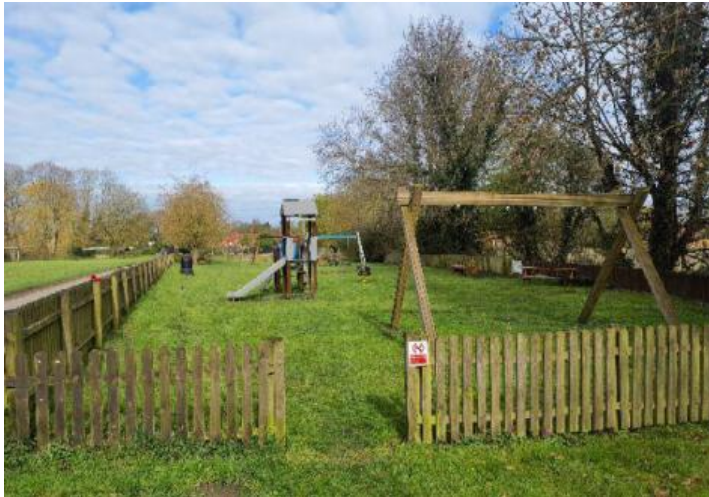
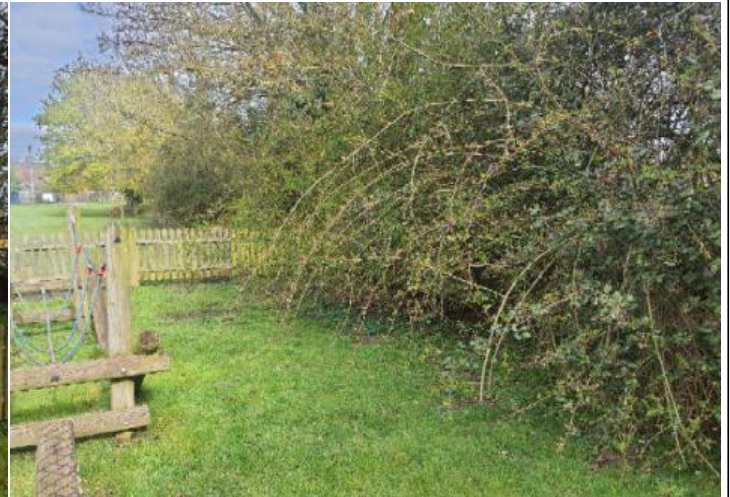
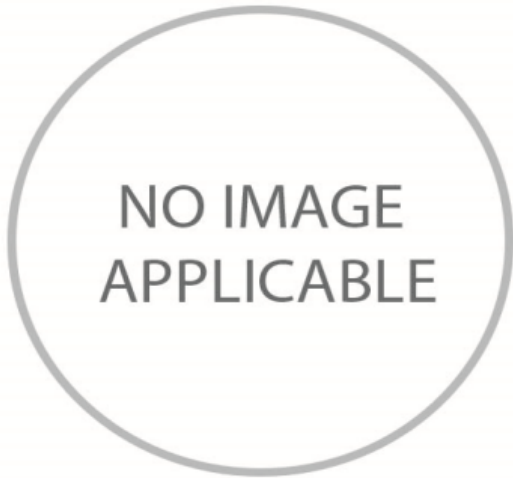
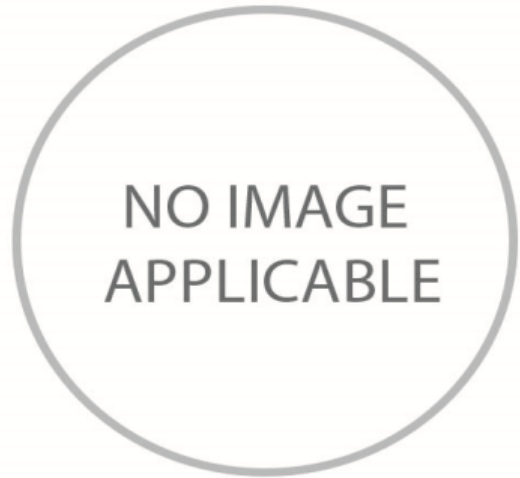
Item: Ancillary Items - Site General
Manufacturer: Owner/Operator

Finding: The adjacent foliage is overhanging

Action: Cut back and maintain

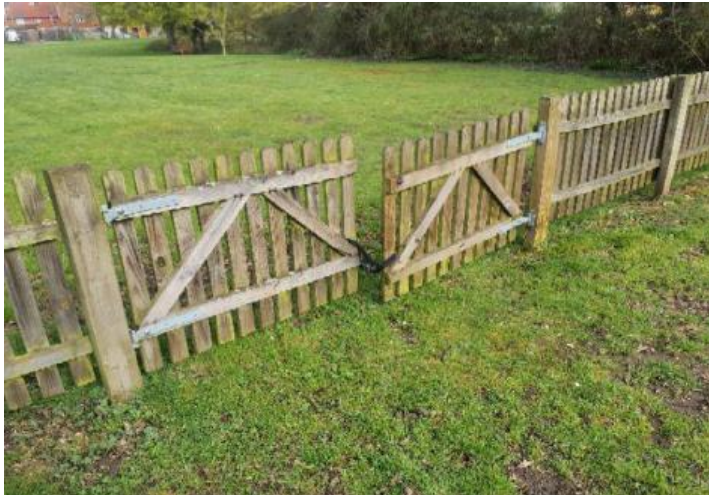
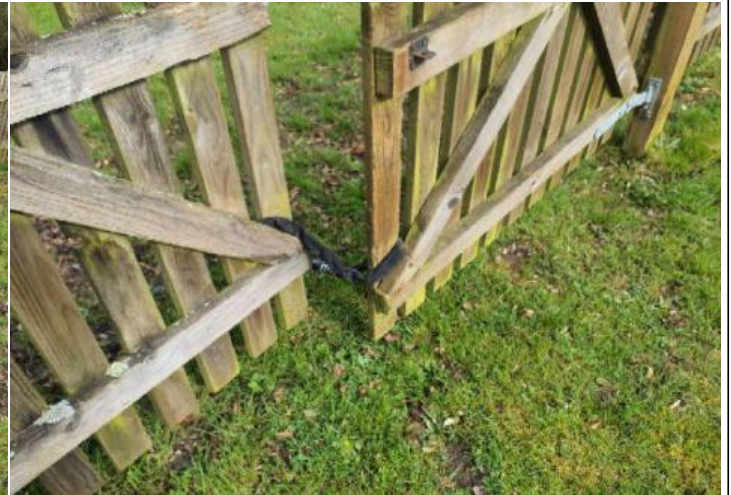
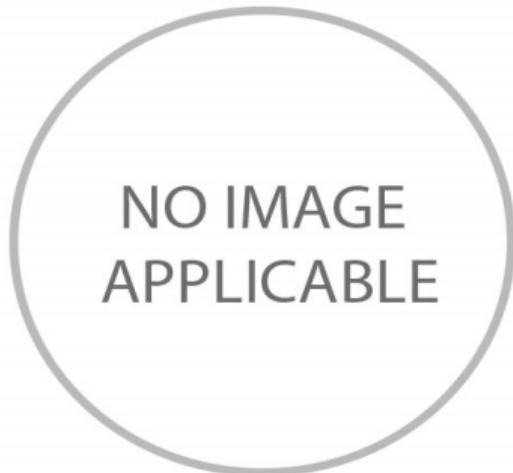
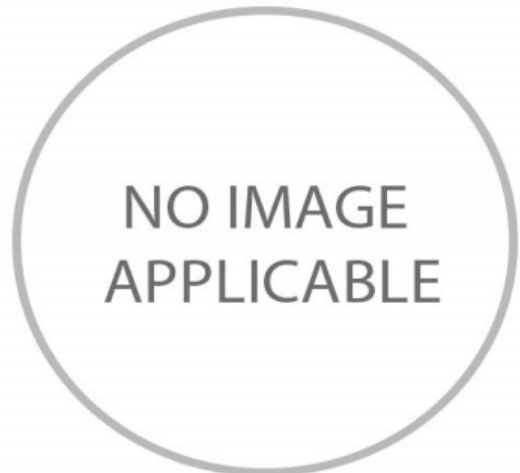
Item: Gates - Gate - Maintenance
Manufacturer: Not Identified

Finding: The maintenance gate was correctly padlocked at the time of inspection, however this means that the inspector was unable to fully assess the gate

Action: Ensure that there are 12mm gaps throughout the full range of motion on gate/s and between leaves where relevant

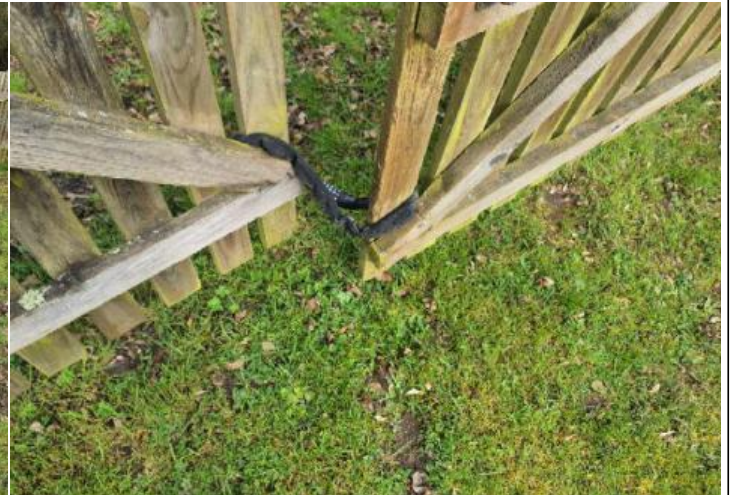
Item: Gates - Gate - Maintenance
Manufacturer: Not Identified

Finding: The gate has no drop bolt sleeves and/or drop bolts fitted

Action: Provide drop bolt sleeves and/or drop bolts

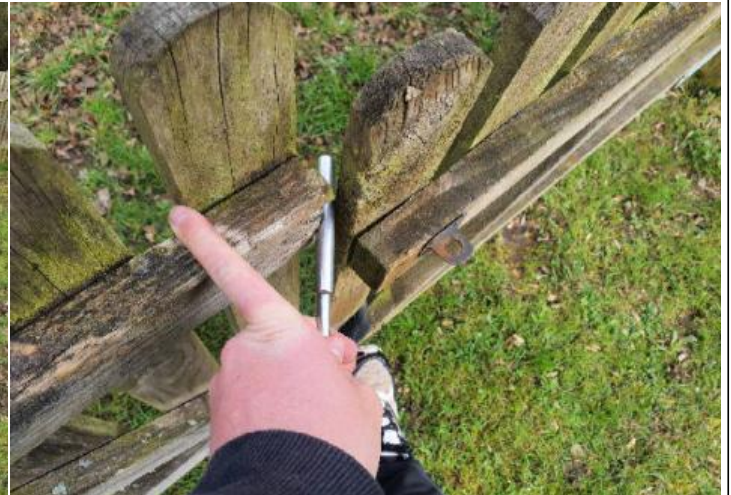
Item: Gates - Gate - Maintenance
Manufacturer: Not Identified

Finding: There are openings that are less than 12mm that could trap or crush fingers

Action: Provide a 12mm gap throughout full range of motion at both sides of gate

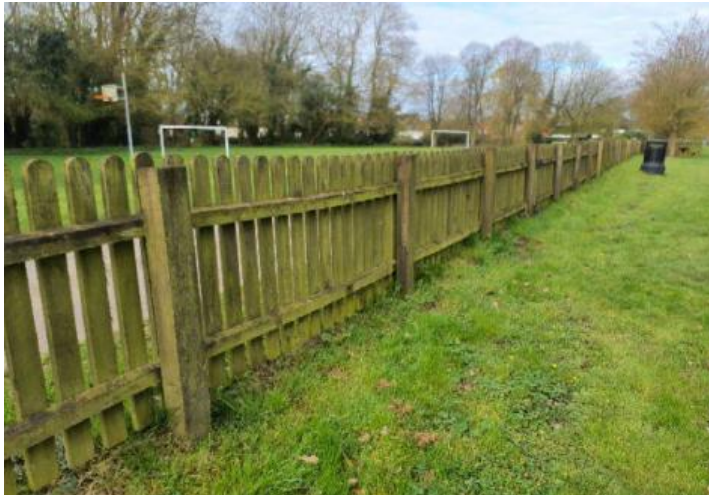
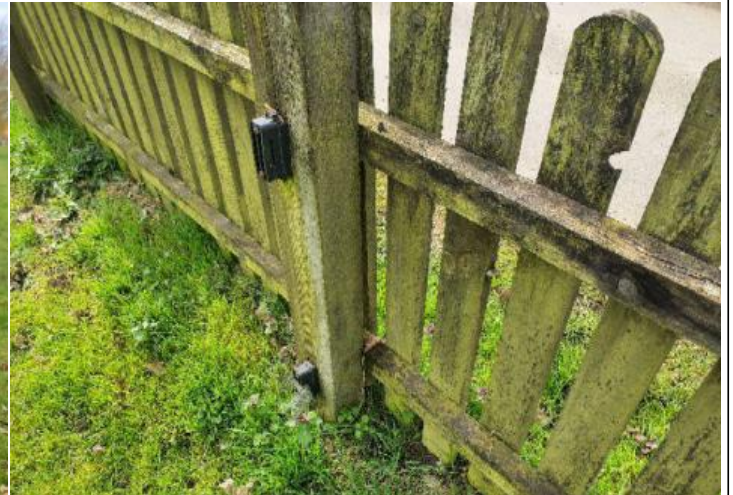
Item: Fences - Fence
Manufacturer: Not Identified

Finding: There are redundant brackets attached to the fence

Action: Remove

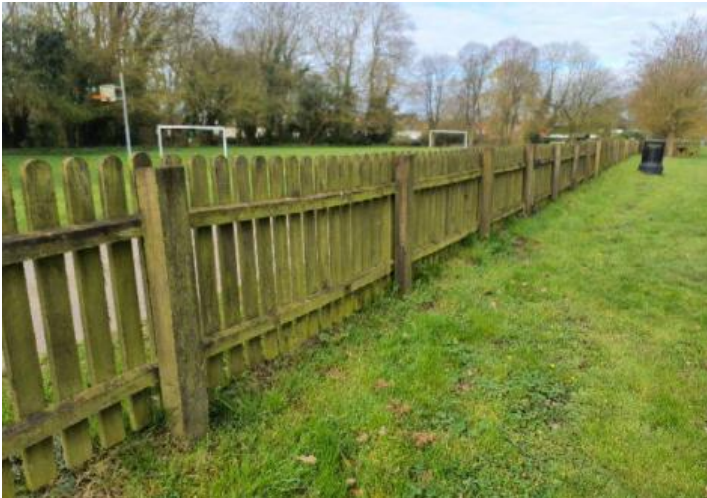
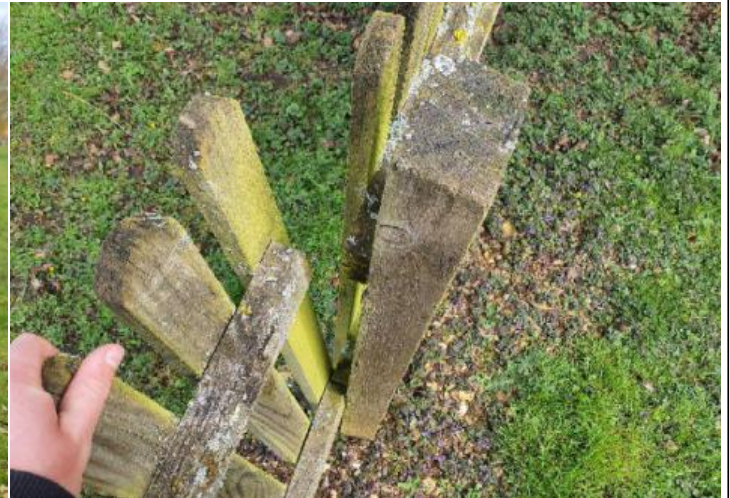
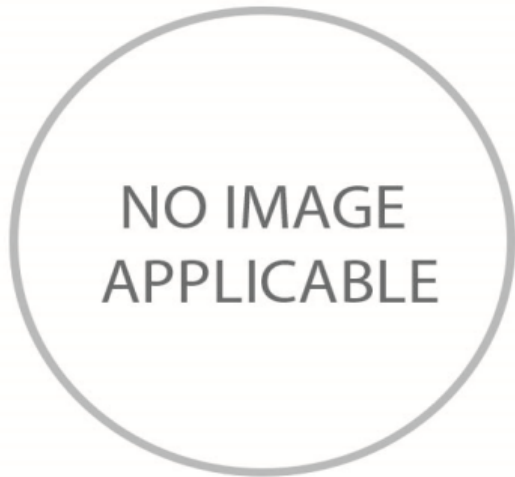
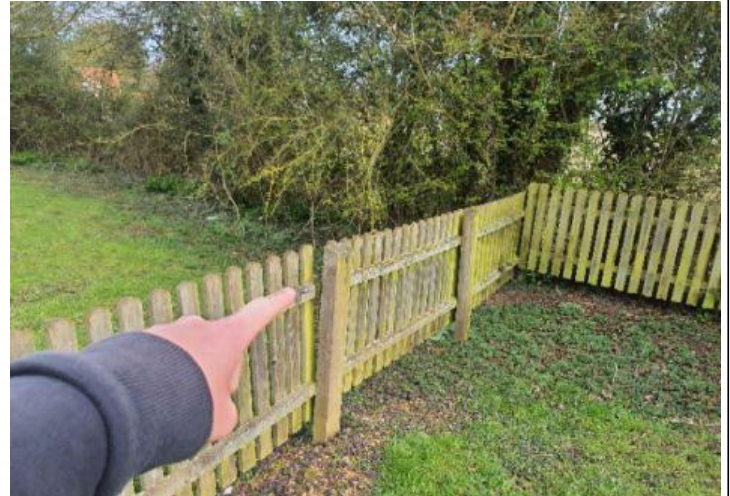
Item: Fences - Fence
Manufacturer: Not Identified

Finding: The fence is unsecured in places

Action: Secure

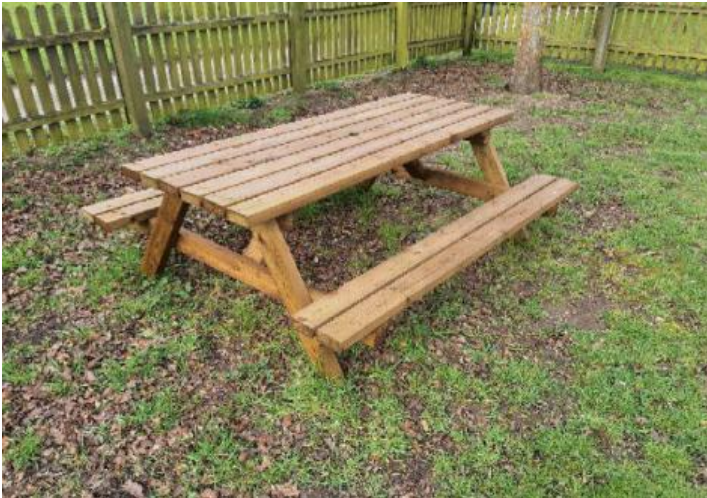
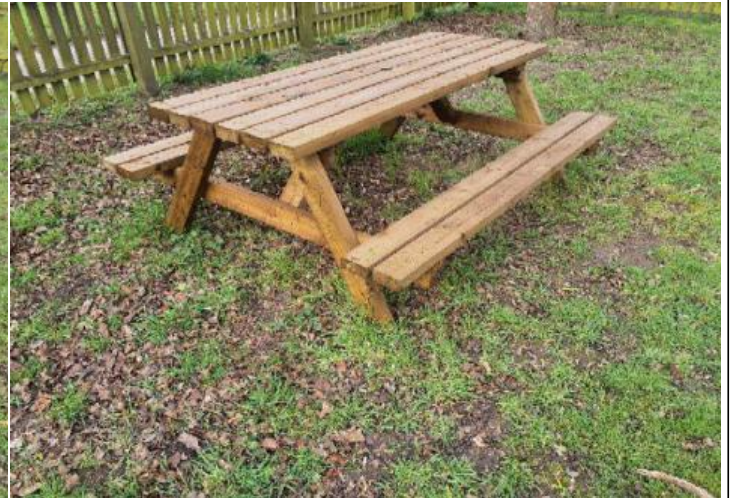
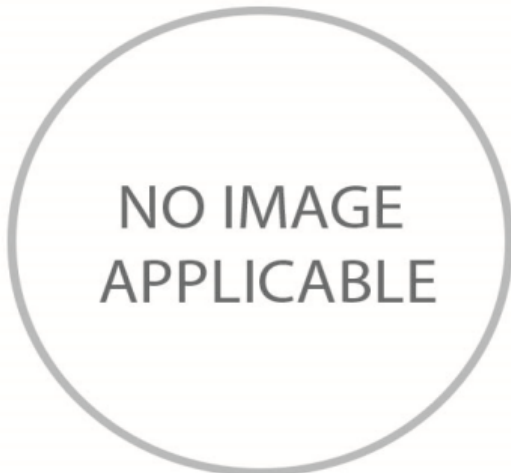
Item: Ancillary Items - Picnic Table
Manufacturer: Not Identified

Finding: The table/s is/are not secured to the ground and there is some potential for the item/s to be moved within falling spaces of equipment

Action: Secure to the ground

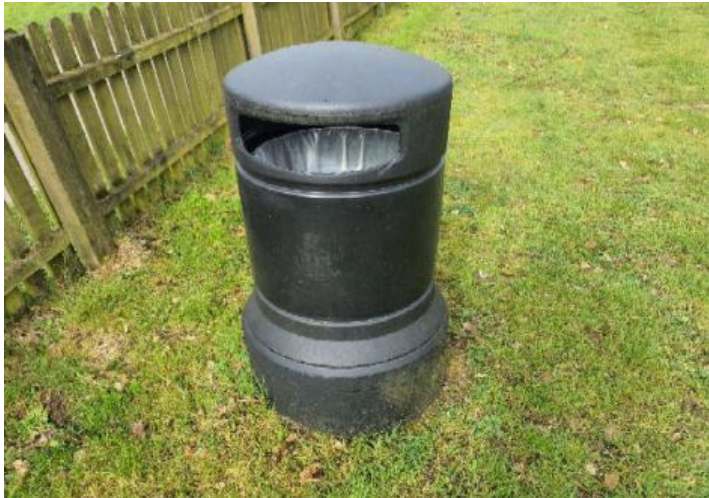
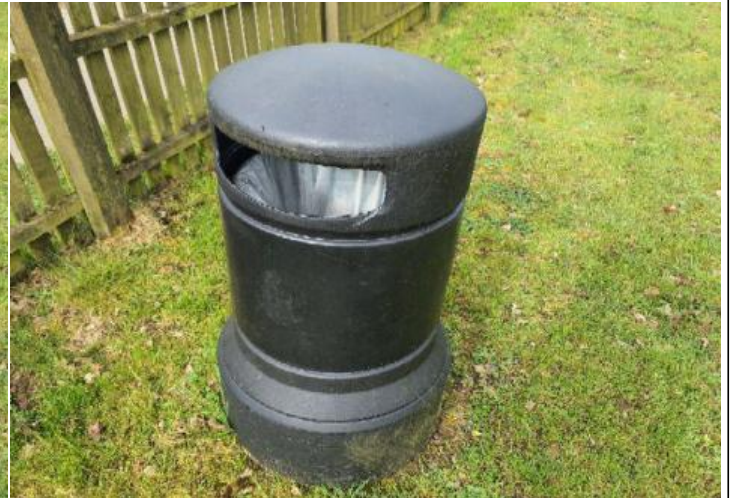
Item: Ancillary Items - Litter Bin
Manufacturer: Not Identified

Finding: The lid or door of the litter bin is not secured

Action: Ensure the lid or door is kept locked

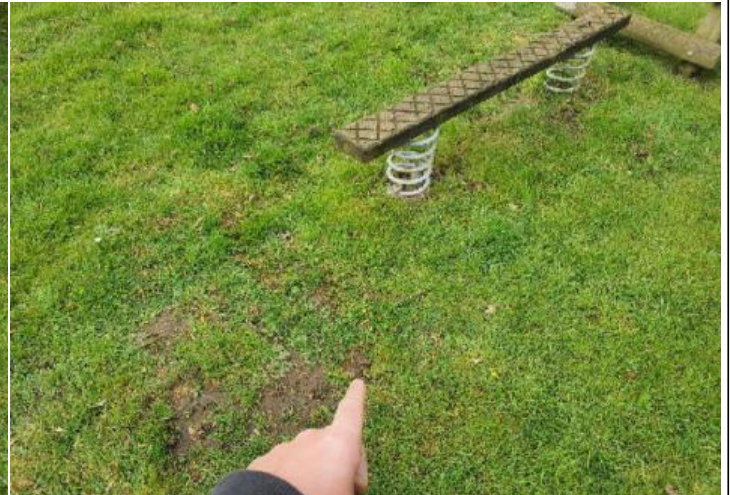
Item: Activity Equipment - Spring Balance Beam **Risk Level:** V - Very Low Risk
Manufacturer: Fenland Leisure Products **Surface:** Grass

Finding: The redundant post forms a hard object within the impact area of the equipment in contravention of the requirements of BS EN 1176 Part 1 **Action:** Remove post

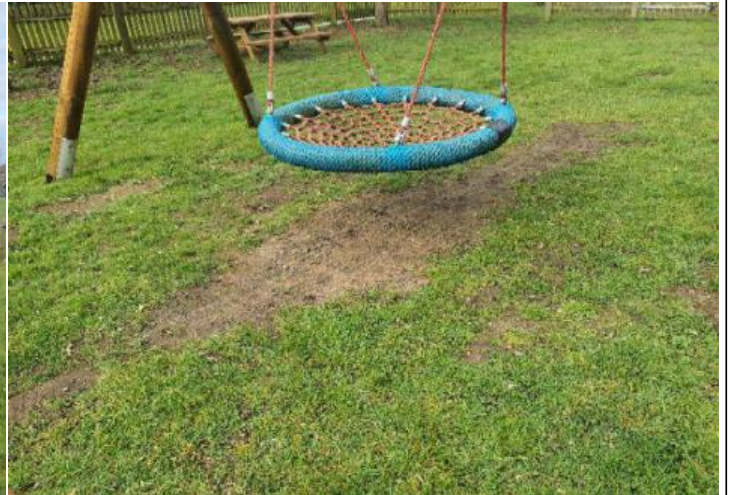
Item: Swings - Basket Swing - Type 1
Manufacturer: NGF Play

Finding: The grass mats are silted up and the soil is compacted; this may have an effect on the impact absorbing properties of the surface. Consideration should be given to HIC testing the surface to verify impact attenuating properties (<https://playinspections.co.uk/inspection-services/safety-surface-testing/>)

Action: Contact our office for a quotation for this service

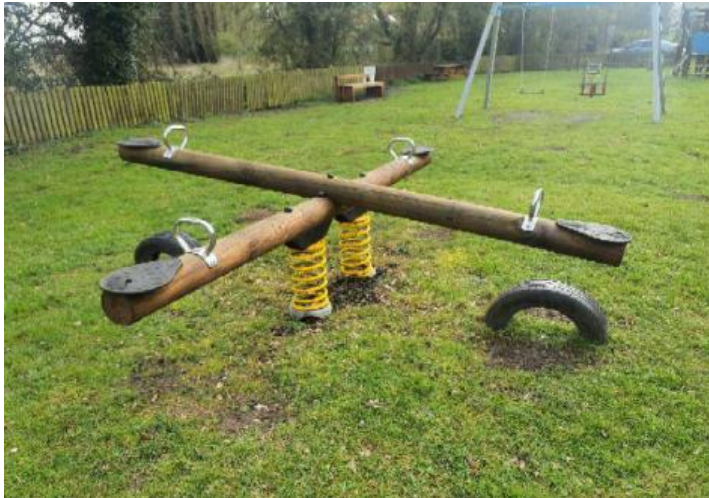
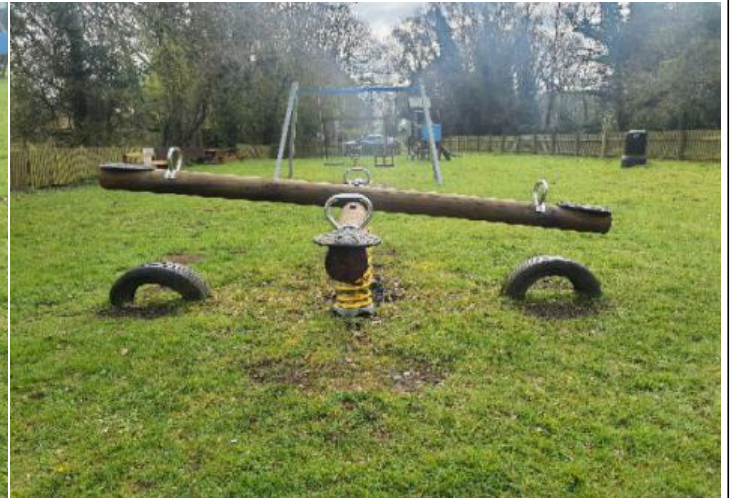
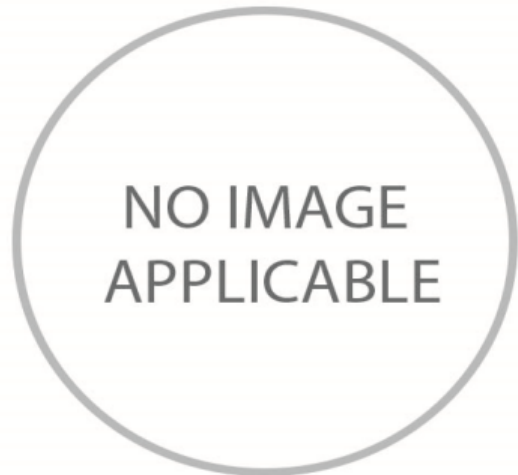
Item: Rocking Equipment - Four Way Springer
Manufacturer: NGF Play

Finding: The item is not level at rest

Action: Adjust

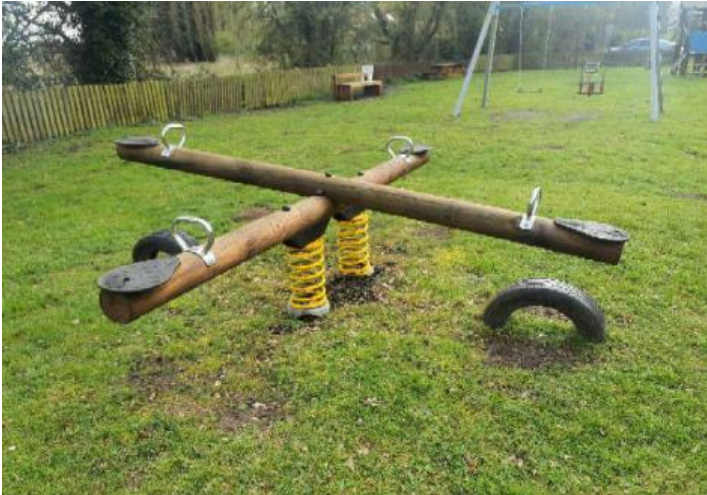
Item: Rocking Equipment - Four Way Springer
Manufacturer: NGF Play

Finding: A number of fixing(s) have worked loose and there is a significant amount of movement
Action: Secure all loose fixings

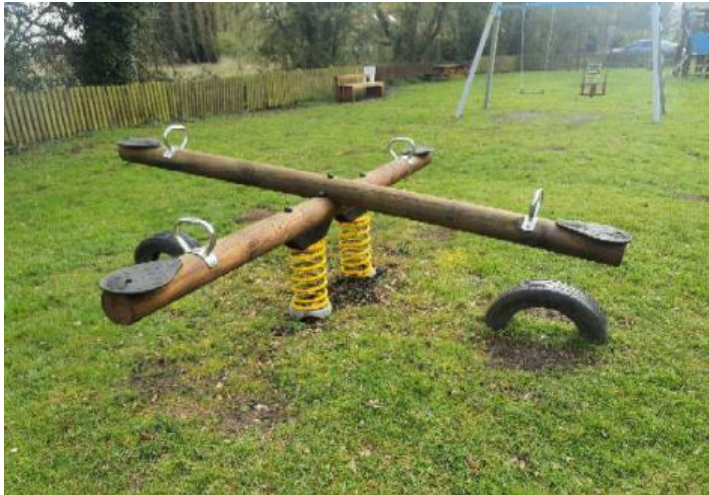
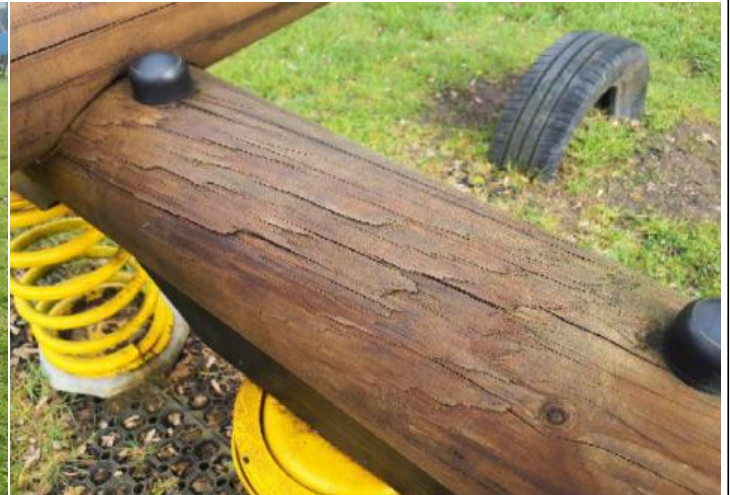
Item: Rocking Equipment - Four Way Springer
Manufacturer: NGF Play

Finding: Parts of the timber are rough or splintered

Action: Remove all rough or sharp edges

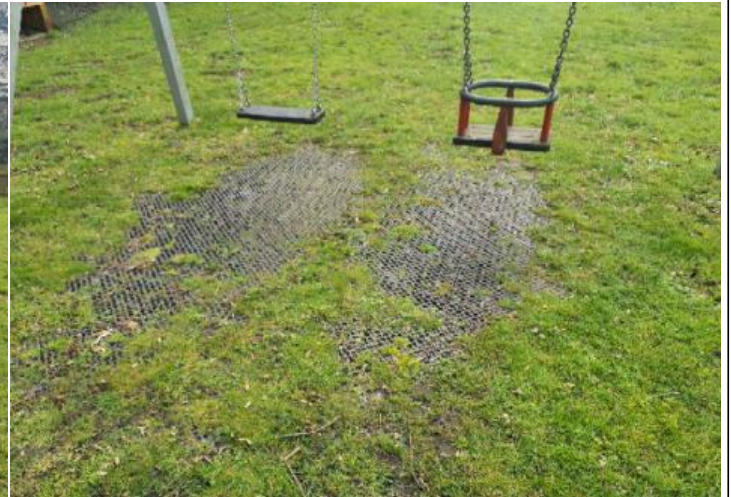
Item: Swings - 1 Bay Mixed Seat, 1 Cradle, 1 Flat
Manufacturer: Vinci Play

Finding: There is a lack of grass growth within the grassmats

Action: Encourage grass growth

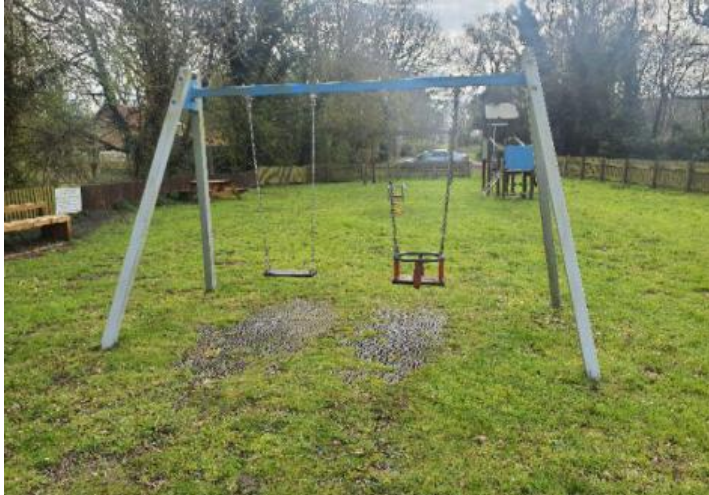
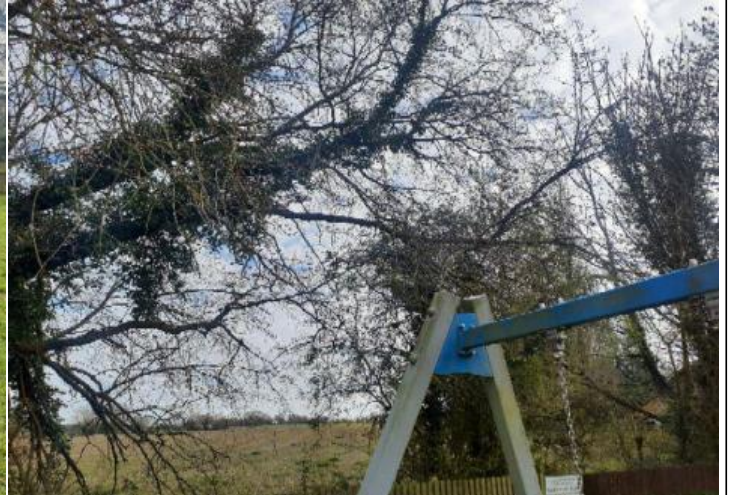
Finding: The tree canopy overhangs the equipment and is less than 2.0m away

Action: Lift tree canopy to ensure a minimum clearance of 2.0m from the equipment

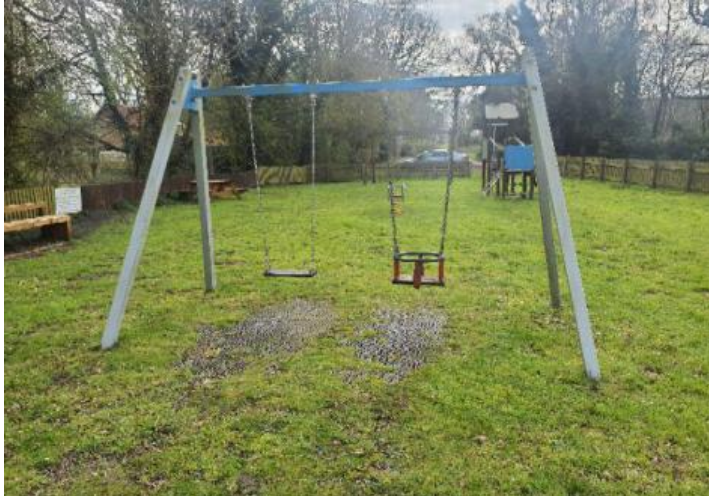
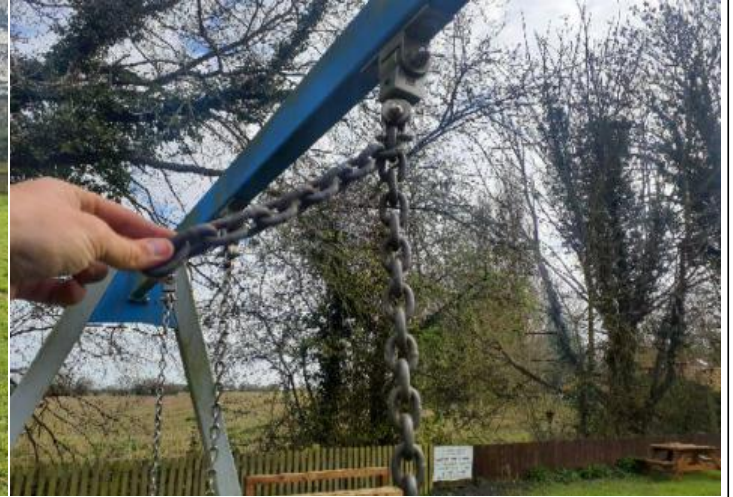
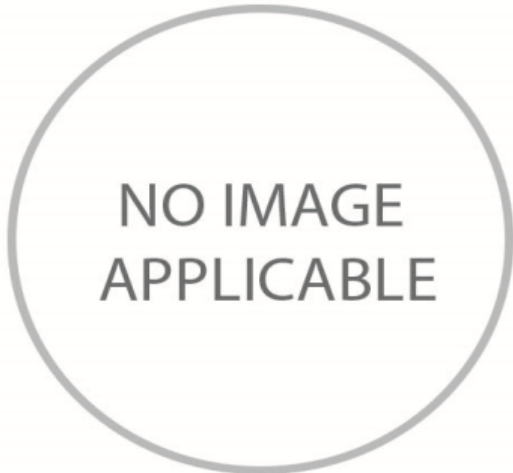
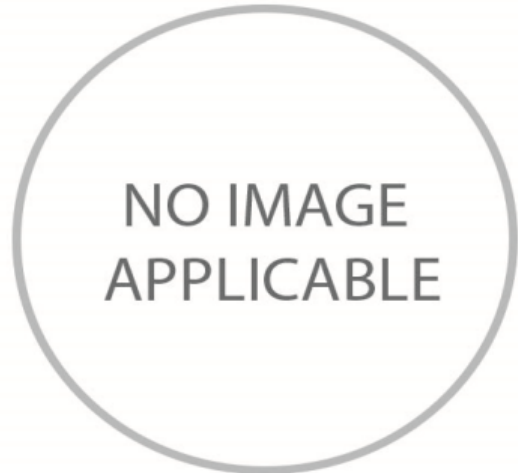
Item: Swings - 1 Bay Mixed Seat, 1 Cradle, 1 Flat
Manufacturer: Vinci Play

Finding: There are excessive chain tails

Action: Cut back excessive chain links

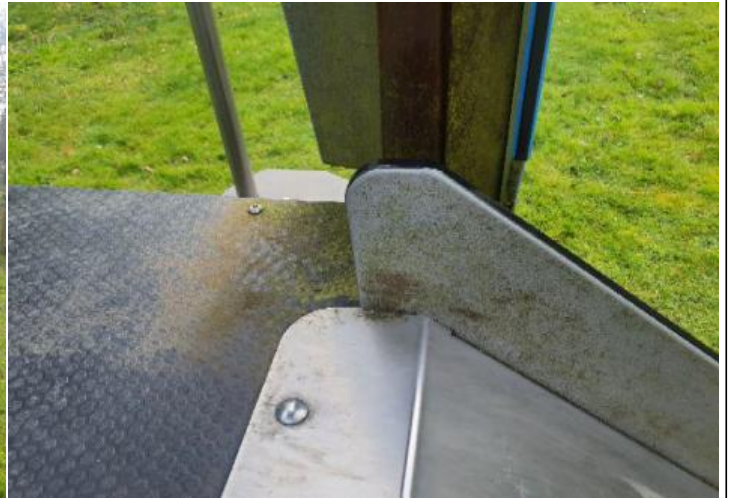
Item: Activity Equipment - Multi Play (Junior)
Manufacturer: Vinci Play

Finding: There is algae or moss on the surface of the equipment

Action: Clean and treat appropriately

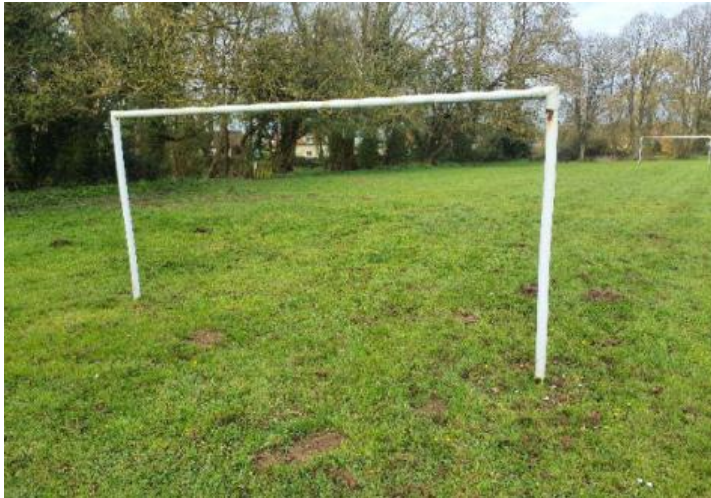
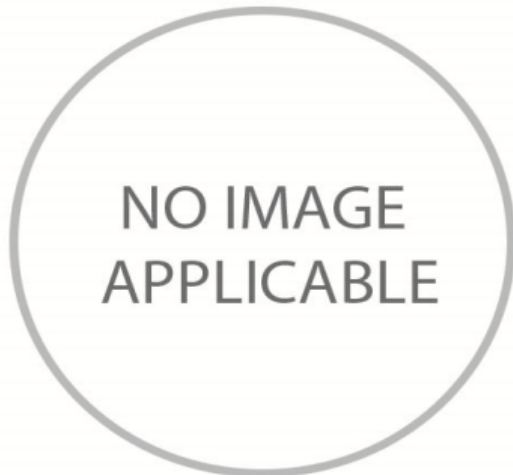
Item: Multi Use Games Area - 5 a side Goals
Manufacturer: Not Identified

Finding: NB: We have undertaken a maintenance inspection only of the football goal(s); full load testing falls outside the scope of our inspection.

Action: Implement load testing as required
